Audio Restoration Project: Repair B&O Bang and Olufsen BeoGram 4000 / 4002 / 4004 / 6000 Tangential Turntable

This article describes how to perform a complete restoration of this model, including taking care of all known failures and defects. The Manufacturer's Service Manual, available from BeoWorld, is an integral component of the proper restoration process.

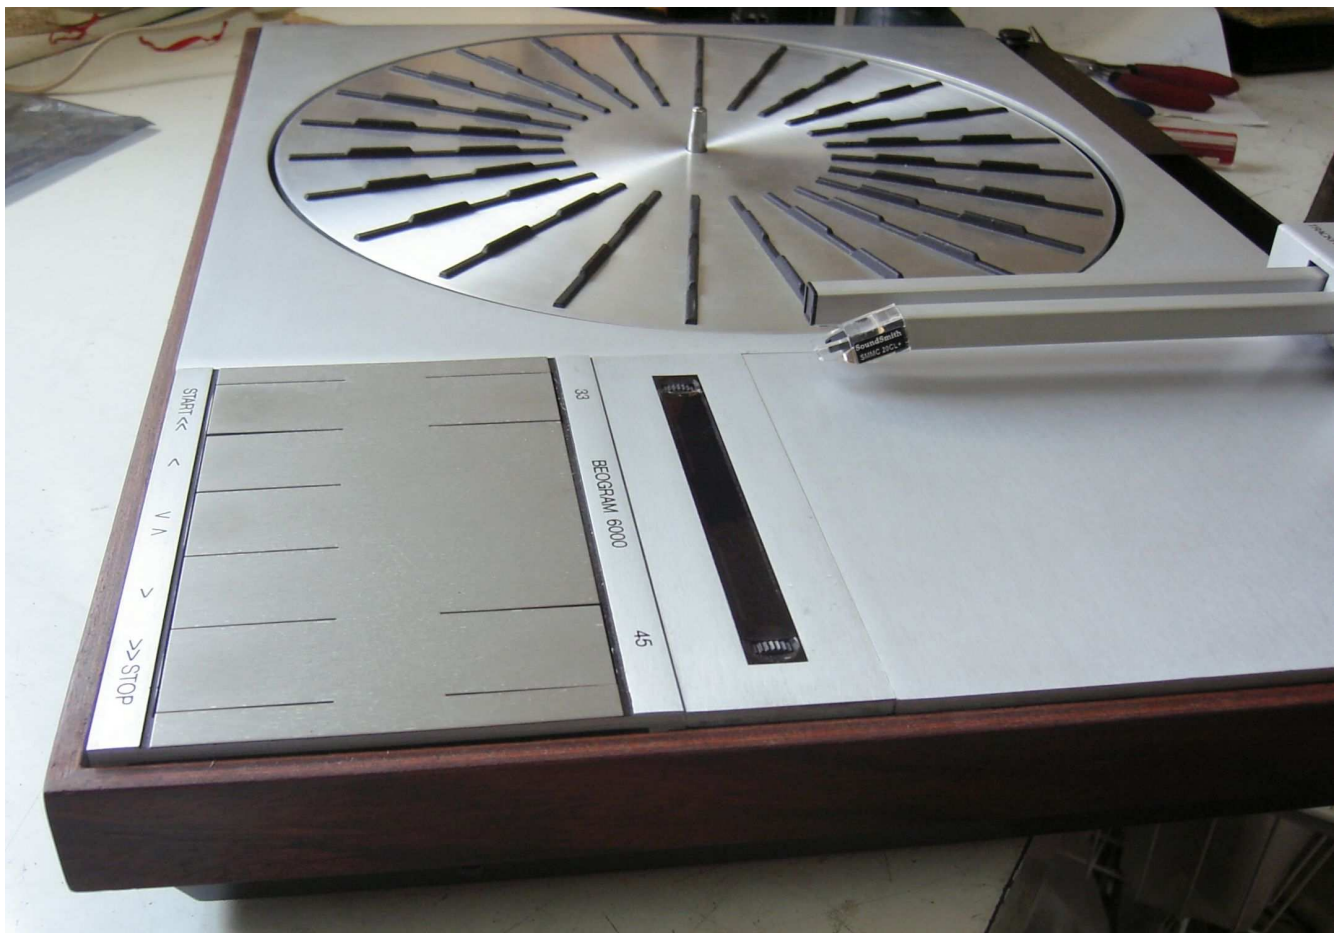
1. Replace the Rubber Drive Belts

When selecting a 45 record, the arm would lower at the 33 LP landing zone, the first-time. The worn out belt was slipping, and the platter didn't reach correct speed in time for the detector circuit to "see" it!

Of course, on the second try, it was already turning, so it would lower correctly at the 45 zone... there's a filter in the detection circuit, and it needs the correct frequency of moving bars under the sensor.

There is also a second smaller belt which moves the tone-arm left and right. This is on the DC motor.

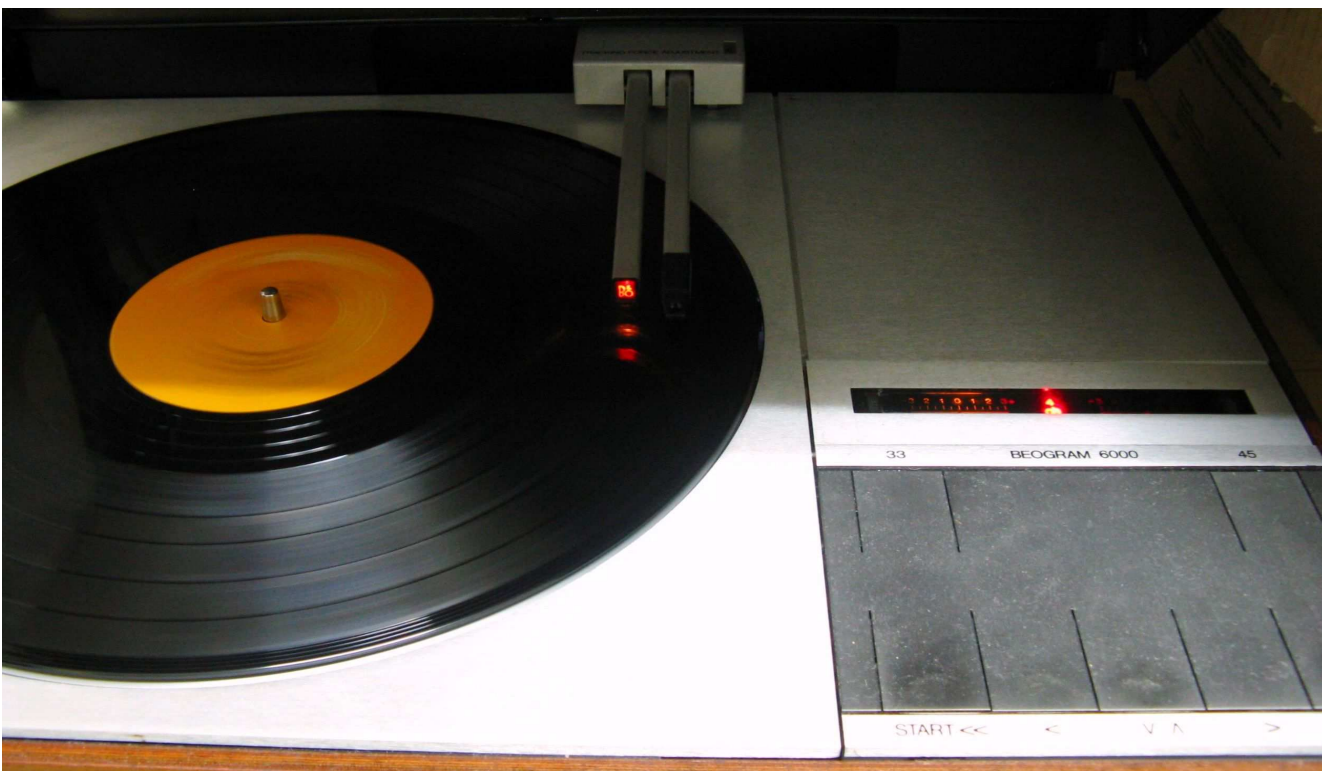
6. 33/45 Speed Problem; PCB 8009024 or 8009033

When pressing START <<, The 33 indicator light (on the left of the red 4ch light), illuminates for a split second, and then immediately, the 45 indicator light illuminates, and remains illuminated (with platter speed 45, as indicated by the light).

This is while the tone arm is still moving to the left slowly over the flat aluminum plate, BEFORE the tone arm even reaches the edge of the platter, let alone the LP.

In short, there was a problem in the 33 circuit, which the previous owner had skillfully hidden by disconnecting the 33 indicator bulb.

When I connected the 33 bulb to the circuit, this above problem appeared.

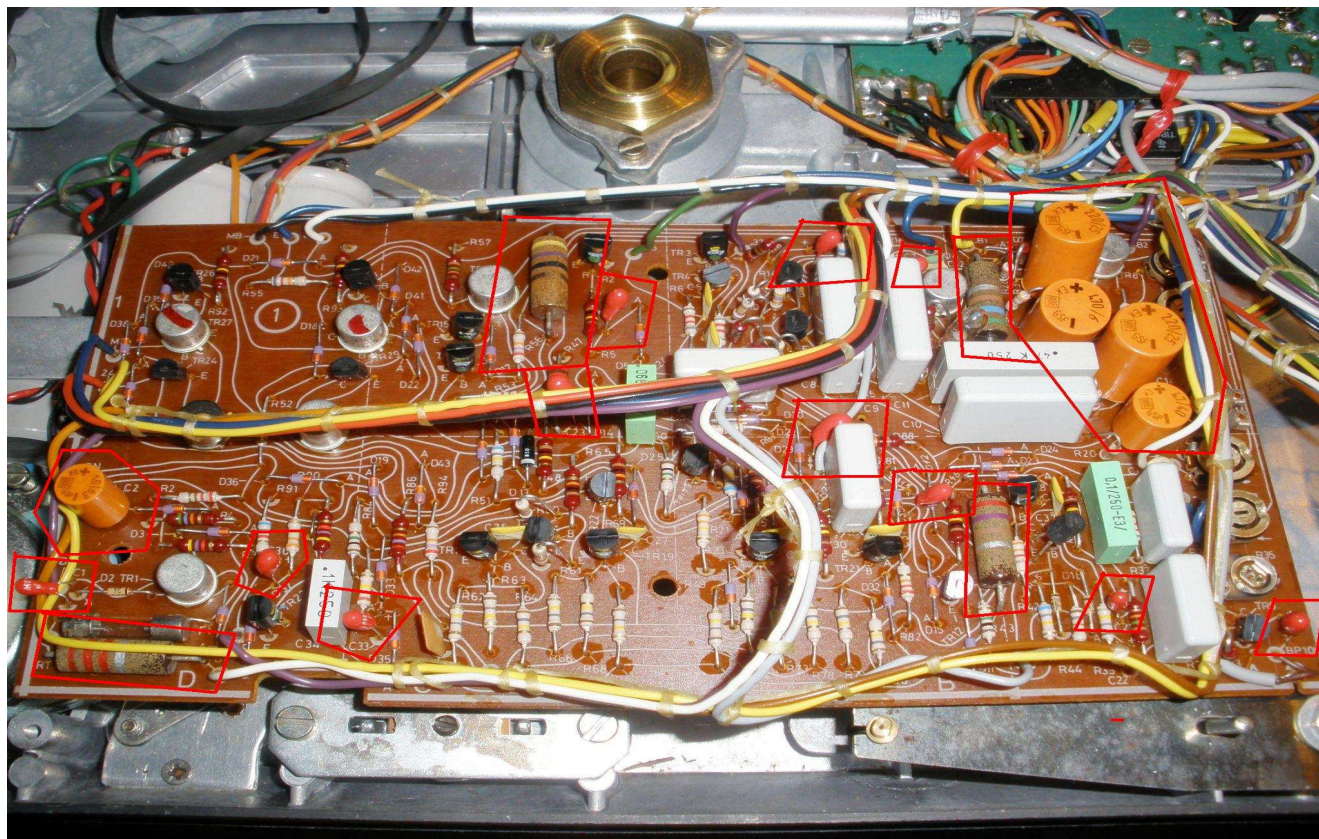
This is the Control PCB before Restoration, showing the components to be replaced

It was repaired by the following:

1. Replacing D6 - 1N4148
2. Replacing C4 and C5 - 3.3nF with Panasonic Polypropylene units
3. Restripping and Resoldering all the coloured wires onto the PCB - many were frayed, and a couple were hanging on by their last strands.
4. Replacing all Electrolytic and Tantalum Capacitors as follows: >10uF with Panasonic FM units, and < 4.7uF with Wima MKS2 and Panasonic Propylene units. Note that some of the Capacitors must be mounted horizontally, to prevent contact with the suspension plate underneath the PCB.
5. The 6 oxidized potentiometers at the right were replaced by Piher PTC10 Cermet units.

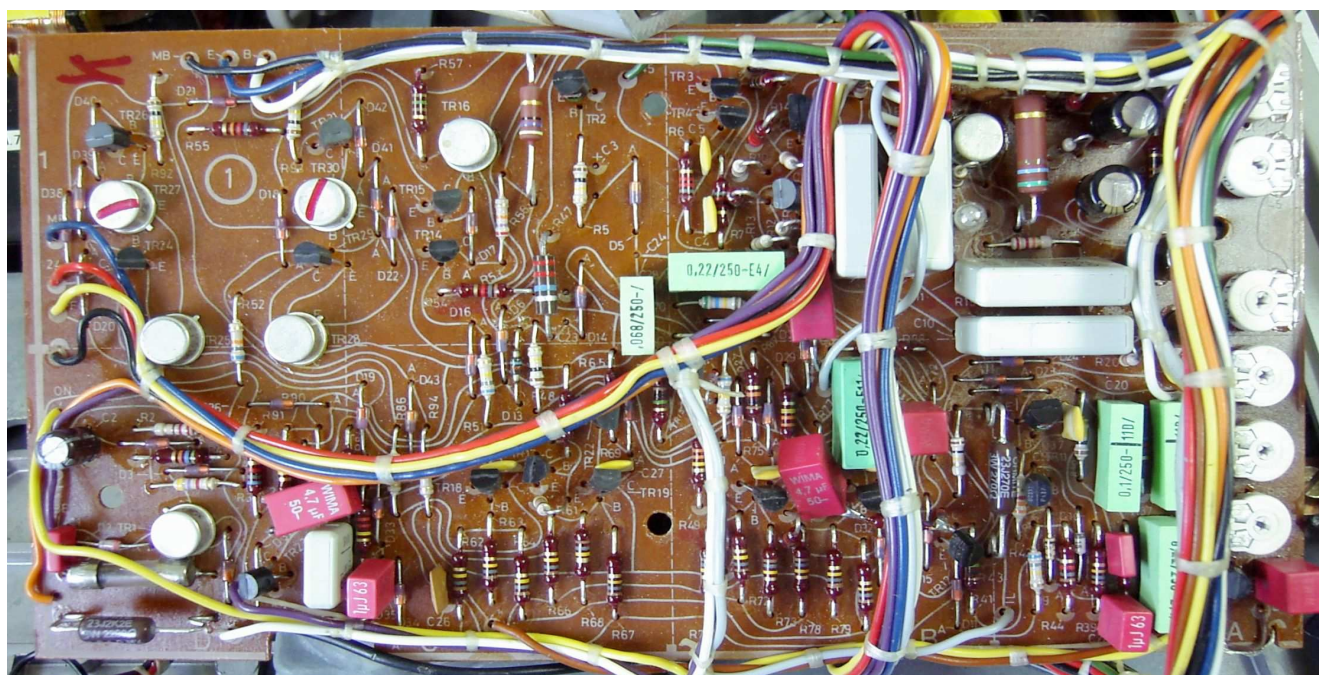
This is the Control PCB after Restoration

The main supply voltage rail to the circuit should be 31V. I was measuring 27.2V. Because all the capacitors and a couple of isolated bad resistors had been replaced already, the place to look was at the semiconductors.

Although all the transistors on the Control PCB appeared to be OK while testing with power off, past experience has shown this not to be the case, when operating under load.

I concentrated on the can transistors on the left side in the above picture. I replaced one pair at a time, with new hFe matched pairs. Modern BC550 (NPN) and BC560 (PNP) are excellent substitutes for the originals.

The following are the results of the change, affecting the 27.2V (31V) supply rail:

TR3 & TR4: +0.3V

TR5 & TR6: +0.2V

TR14 & TR15: +3.1V

TR26 & TR31: +0.15V

With these 8 transistors replaced, the main voltage rail now measured the specified 31V.

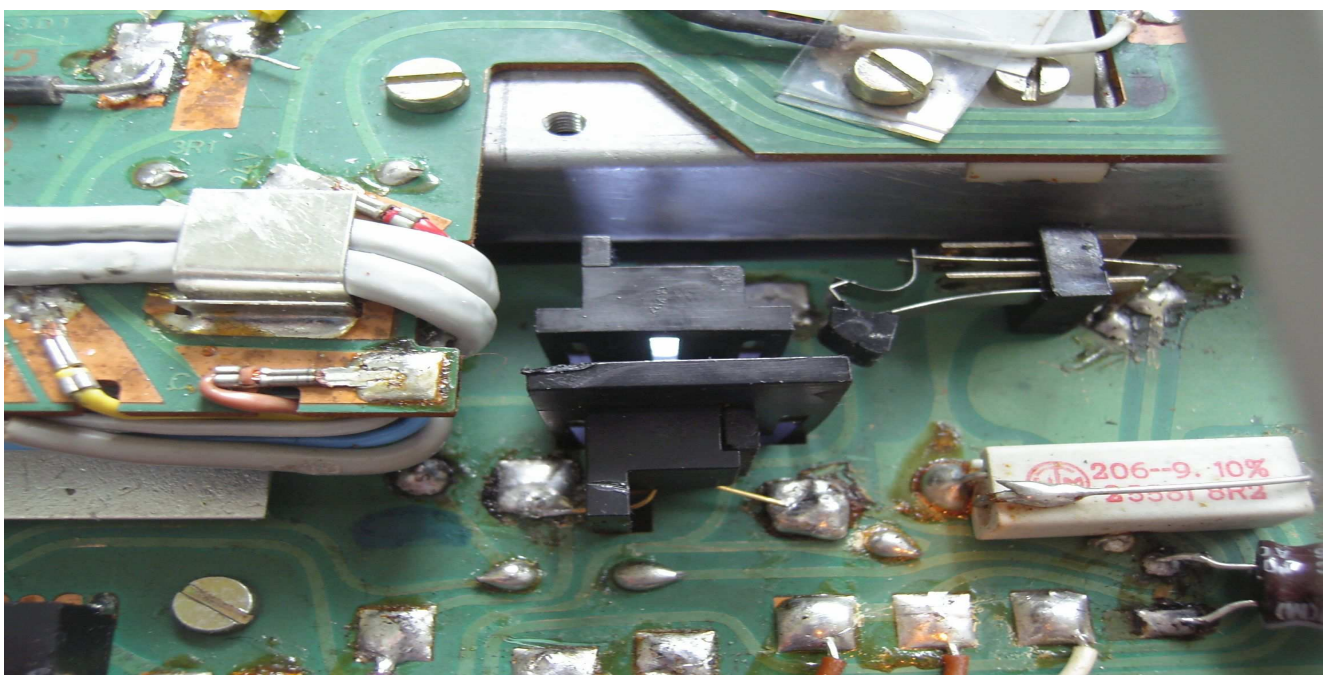
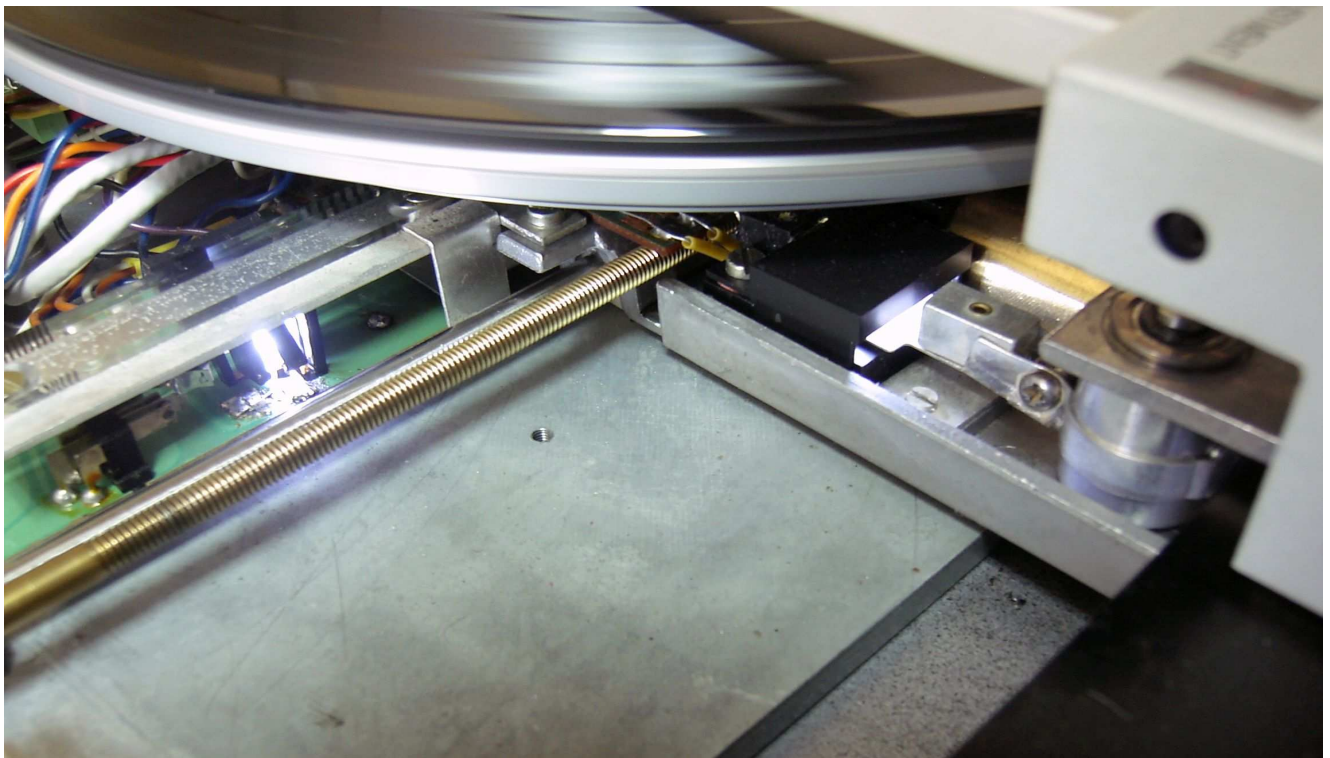
8. PCB 8009032 Modification, LP prematurely ends play

There is an ongoing problem with the Photo-transistor, and having to adjust the incandescent lamp, so that the light reaches the transistor correctly.

I decided to go for overkill - I replaced the 24V 25mA lamp (IL1) with an opaque white medium-intensity 3V LED. This light from this LED is highly directional, and much more intense than the original lamp. So the Photo-transistor, on my unit a Motorola 2N5779, should be able to sense the light more precisely now.

The 82 Ohm resistor (R4) from the Cathode to Ground must also be replaced by a 1Kohm 1W resistor.

Before replacing the clear acrylic ruler with the black stripes, make sure that it is absolutely clean, with no finger- or other marks!

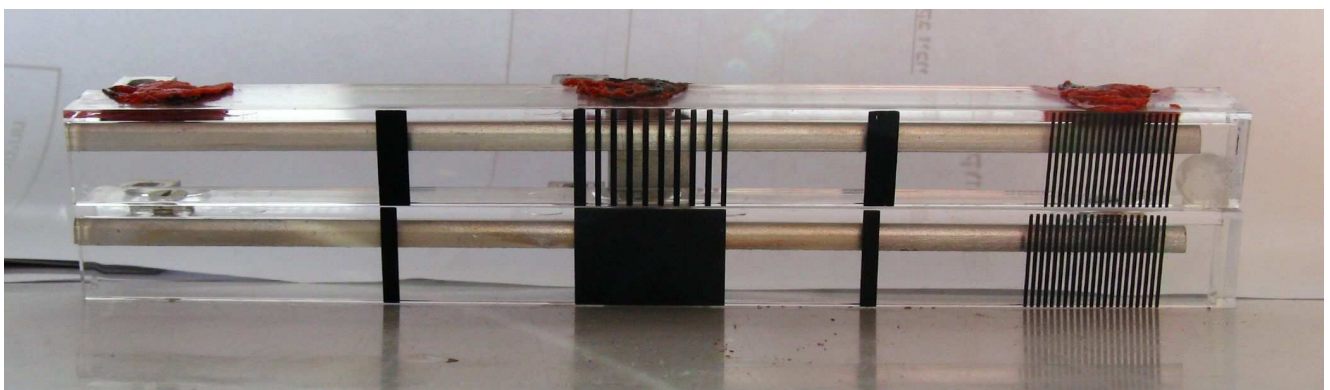
Here are 2 Rulers from the Optical-sensing circuit.

The top one is an early-production unit, and the bottom one is a later-production unit.

The critical difference is at the vertical bars on the right-hand side – this is the End-of-Play signal.

The top one requires the stylus to keep tracking to a later (closer to the centre-hole) position, before signaling "Lift-and-Return".

But if you are playing a later LP, the stylus will never reach that position, so will not "Lift-and-Return"

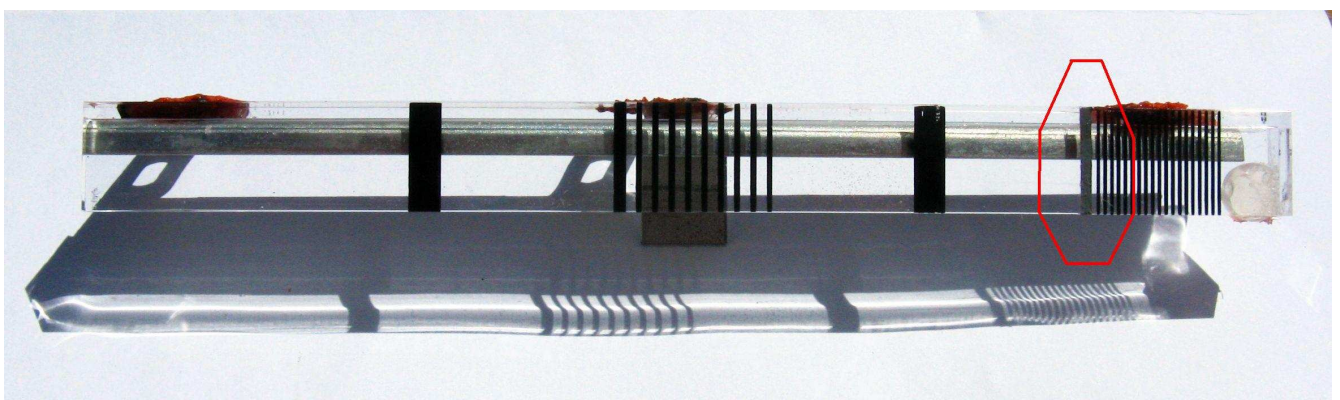
The bolts securing the acrylic ruler to the aluminum mounting bar have been sealed with old-style red sealing wax.

The solution is to add a single wide stripe at that position, as shown below. The stylus will then "Lift-and-Return" correctly.

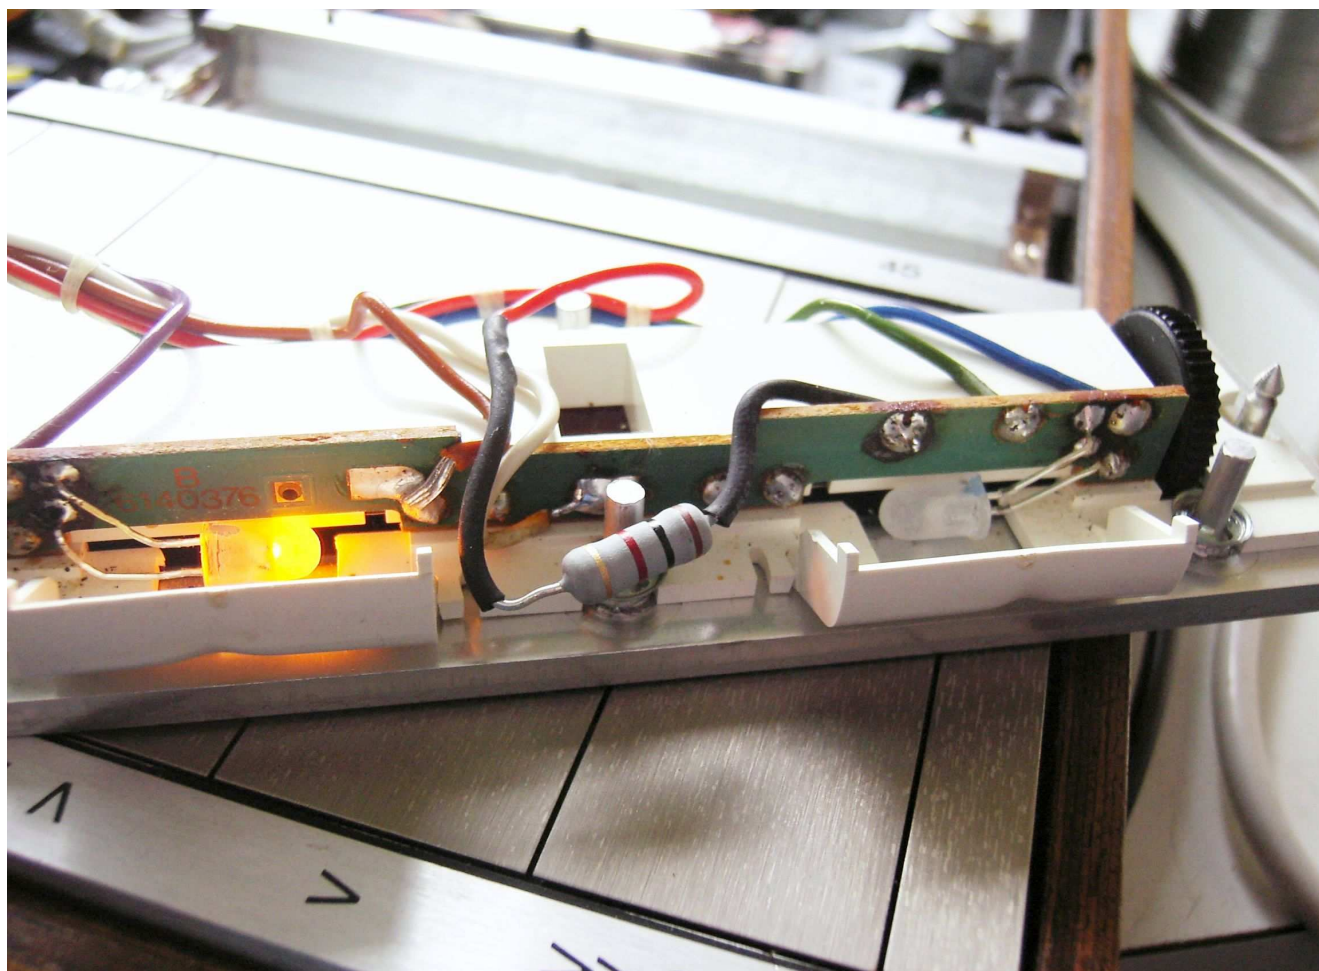
10. 33 / 45 Speed Indicator LED upgrade

The 33 and 45 indicator lamps heat up, and deform their plastic housings.

In the picture, on the white plastic hinged shields, you can see the yellowish damage, due to heat emitted by the standard incandescent lamps.

Current to illuminate the 33/45 Speed lights is supplied by the Red wire.

The voltage present on the Red wire is 22.8VDC positive, which has to be reduced to about 2 Volts.

I chose a 1 Watt resistor (1/2 Watt would normally be enough), because the resistor carries the excess voltage, and heats up. Using a 1 Watt resistor, results in a much cooler resistor.

I unsoldered the Red wire from the PCB, and soldered one end of the resistor in its place.

I soldered the other end of the resistor to the Red wire.

I placed the resistor at a small distance from the white plastic housing (around the metal bolt), to eliminate the possibility of heat damage.

The LED's must be sanded lightly to give an opaque appearance, to distribute the light evenly.

I marked the -ve lead of the LED with a blue marker, which you can see faintly on the upper edge of the LED. If the LED's polarity is incorrect, it will not illuminate.

In the picture, the LED's upper conductor is -ve, and the lower is +ve.

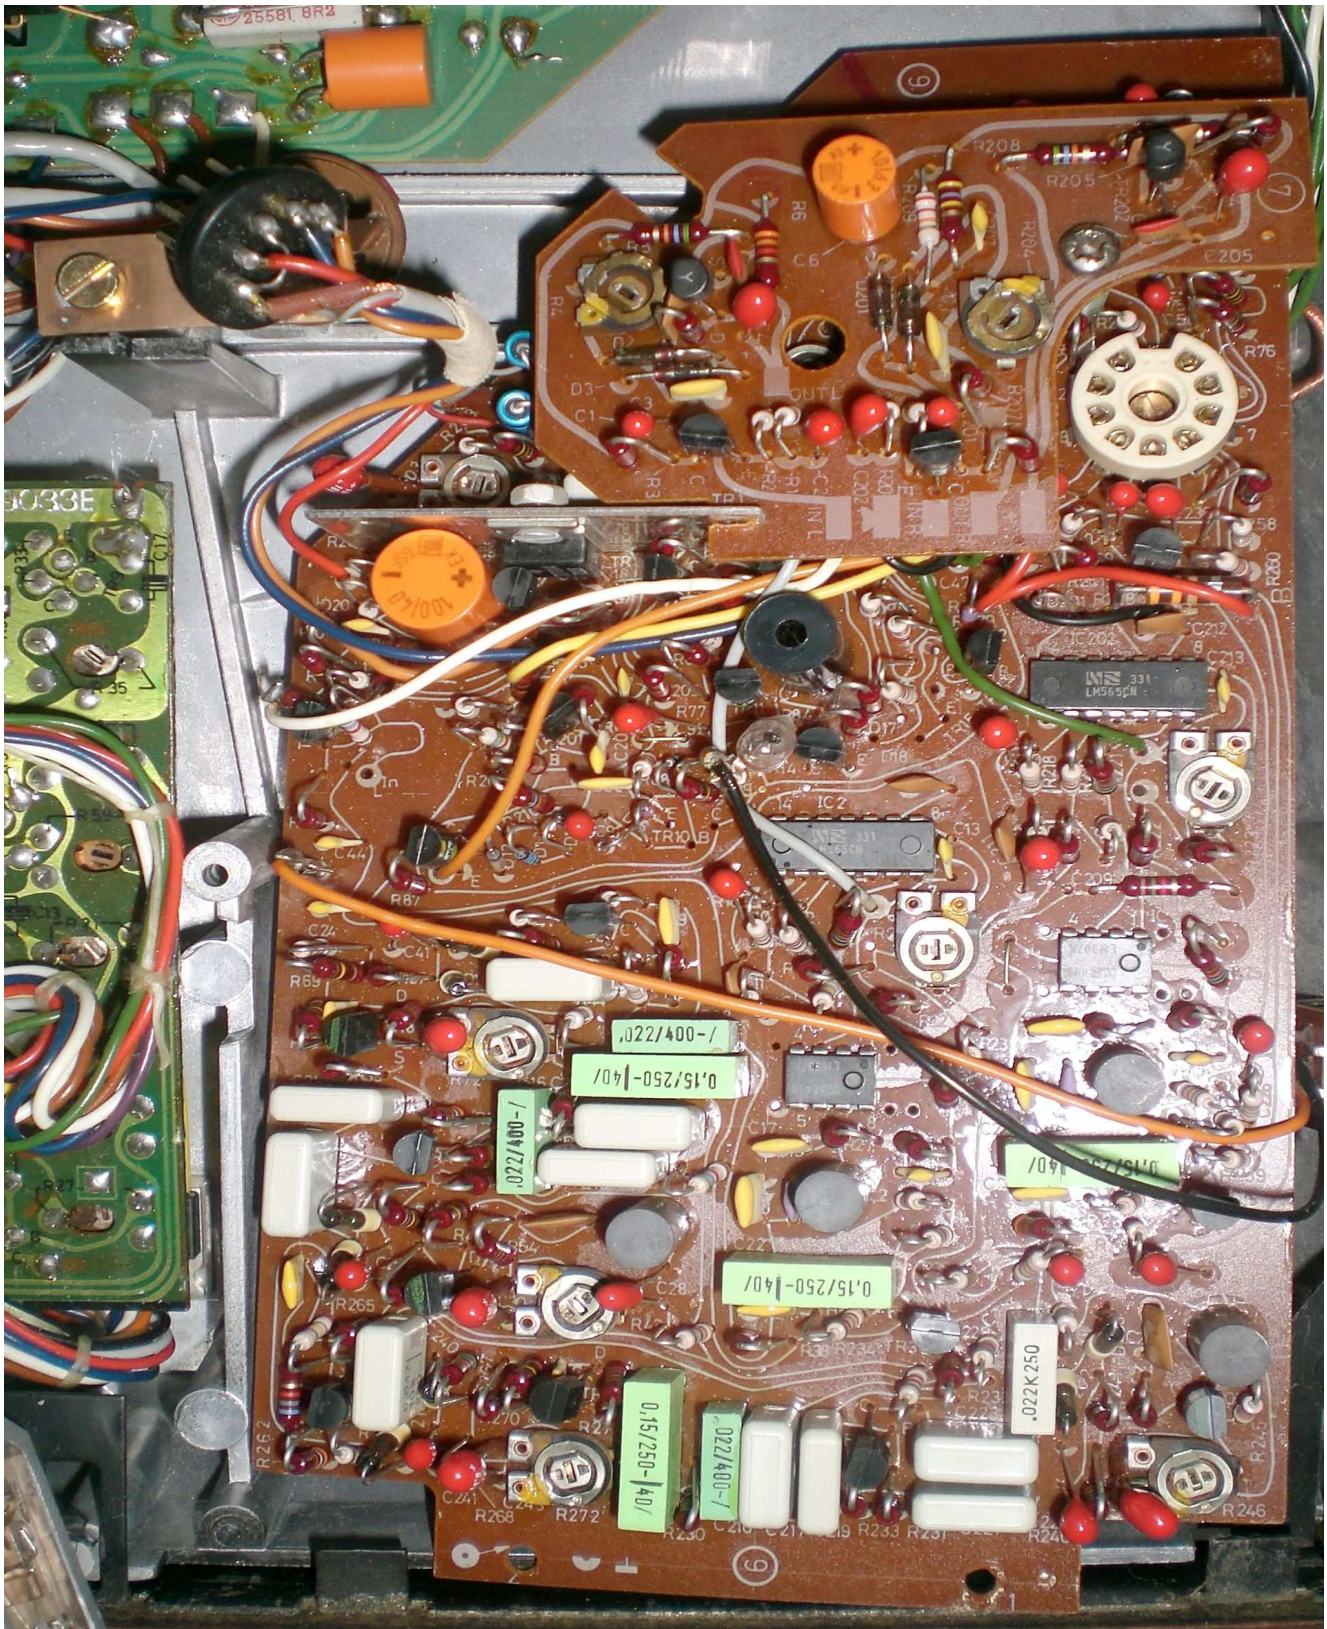
This is the RIAA PCB before Modification:

I replaced all the Electrolytic and Tantalum Caps with a nice blend of Panasonic FM and ECQP, Elna Silmic II, and Wima MKS2 caps, and the potentiometers with Bourns 3352 Cermet units.

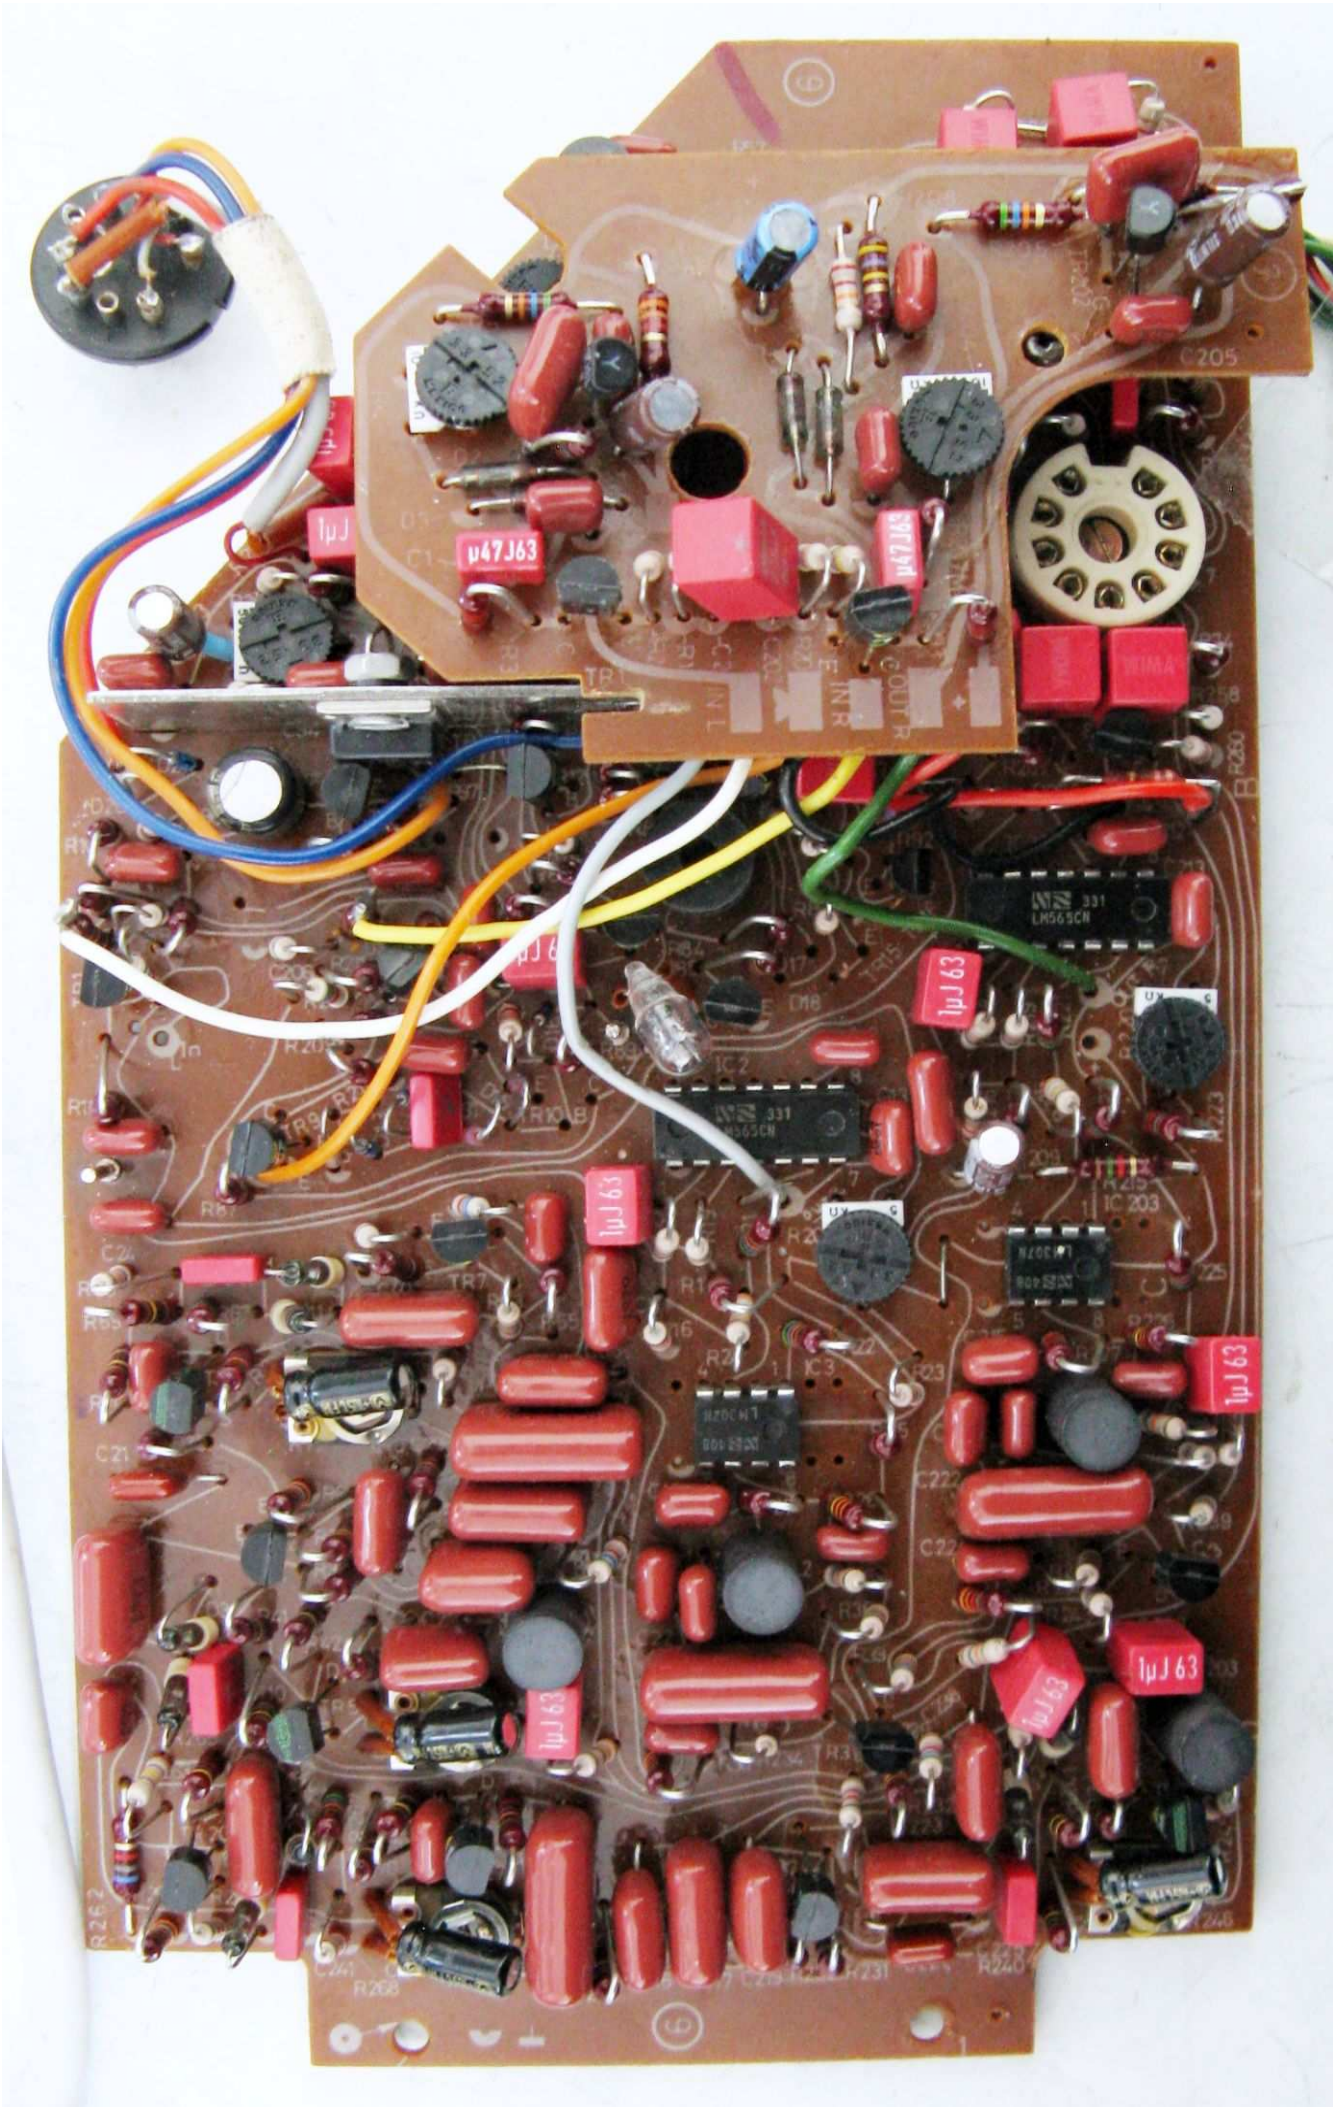
This is the RIAA PCB after Modification:

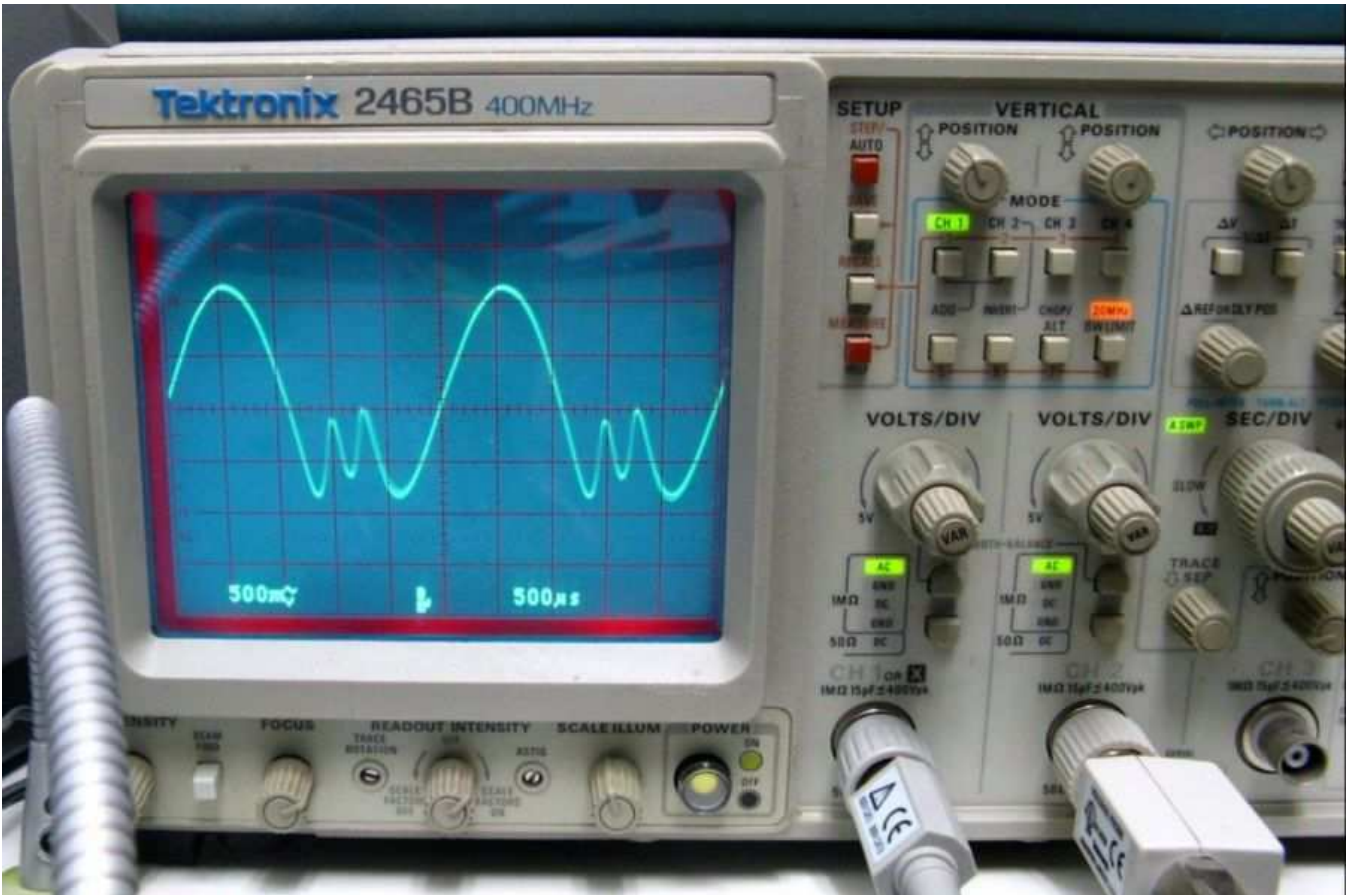
13. This shows the CD4 alignment signal on the RIAA amplifier adjusted according to the Service Manual.

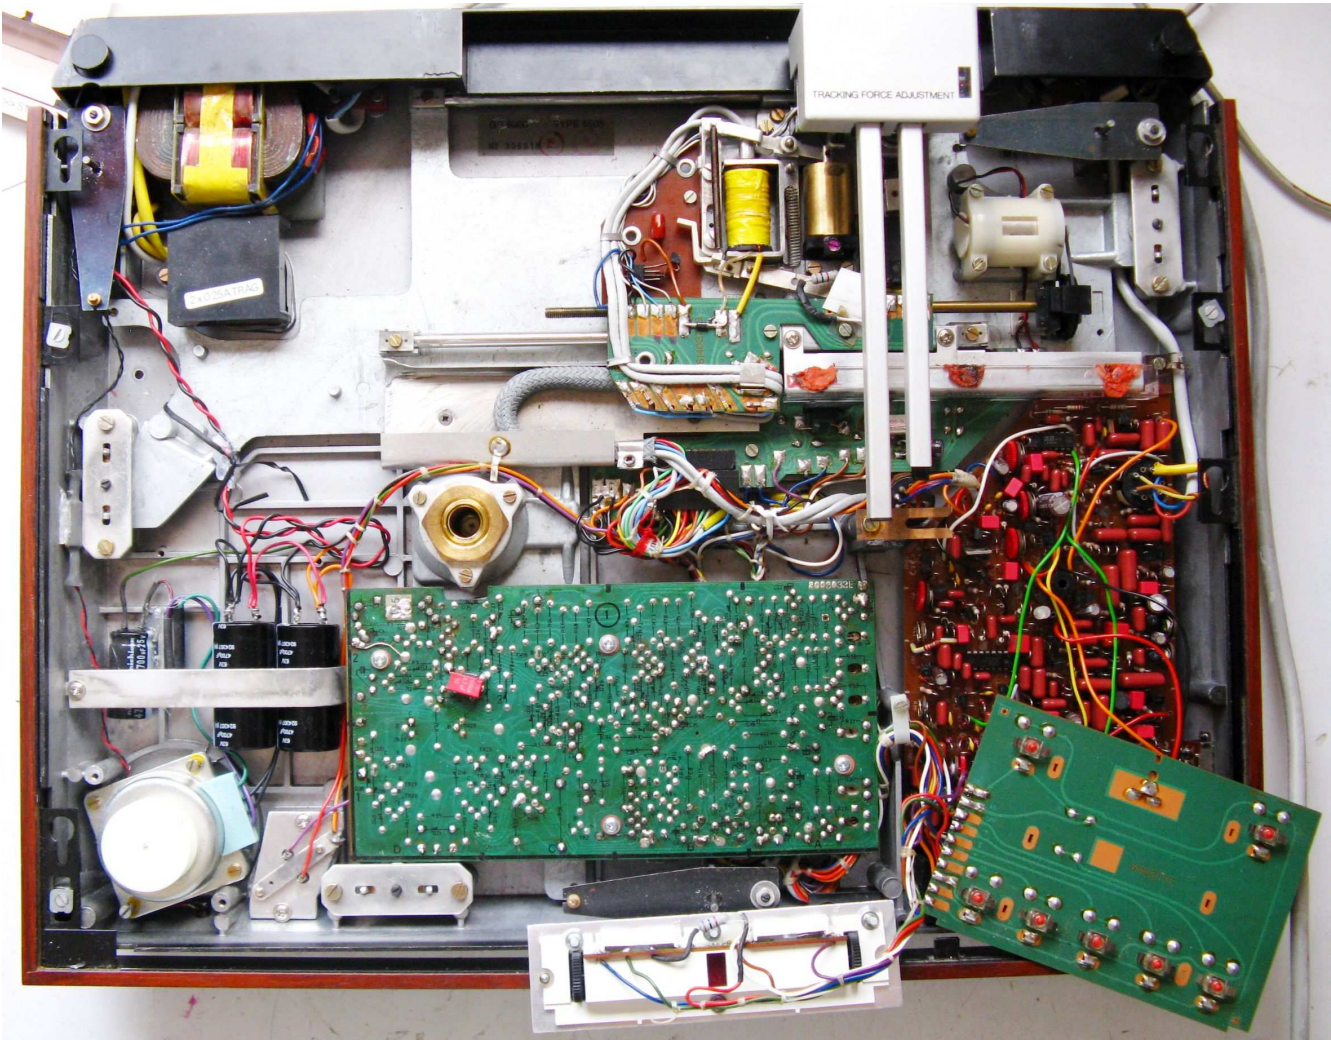
14. This is the totally restored interior
