Audio Restoration Project: Repair B&O Bang and Olufsen BeoGram 4500 Type 59xx Tangential Turntable

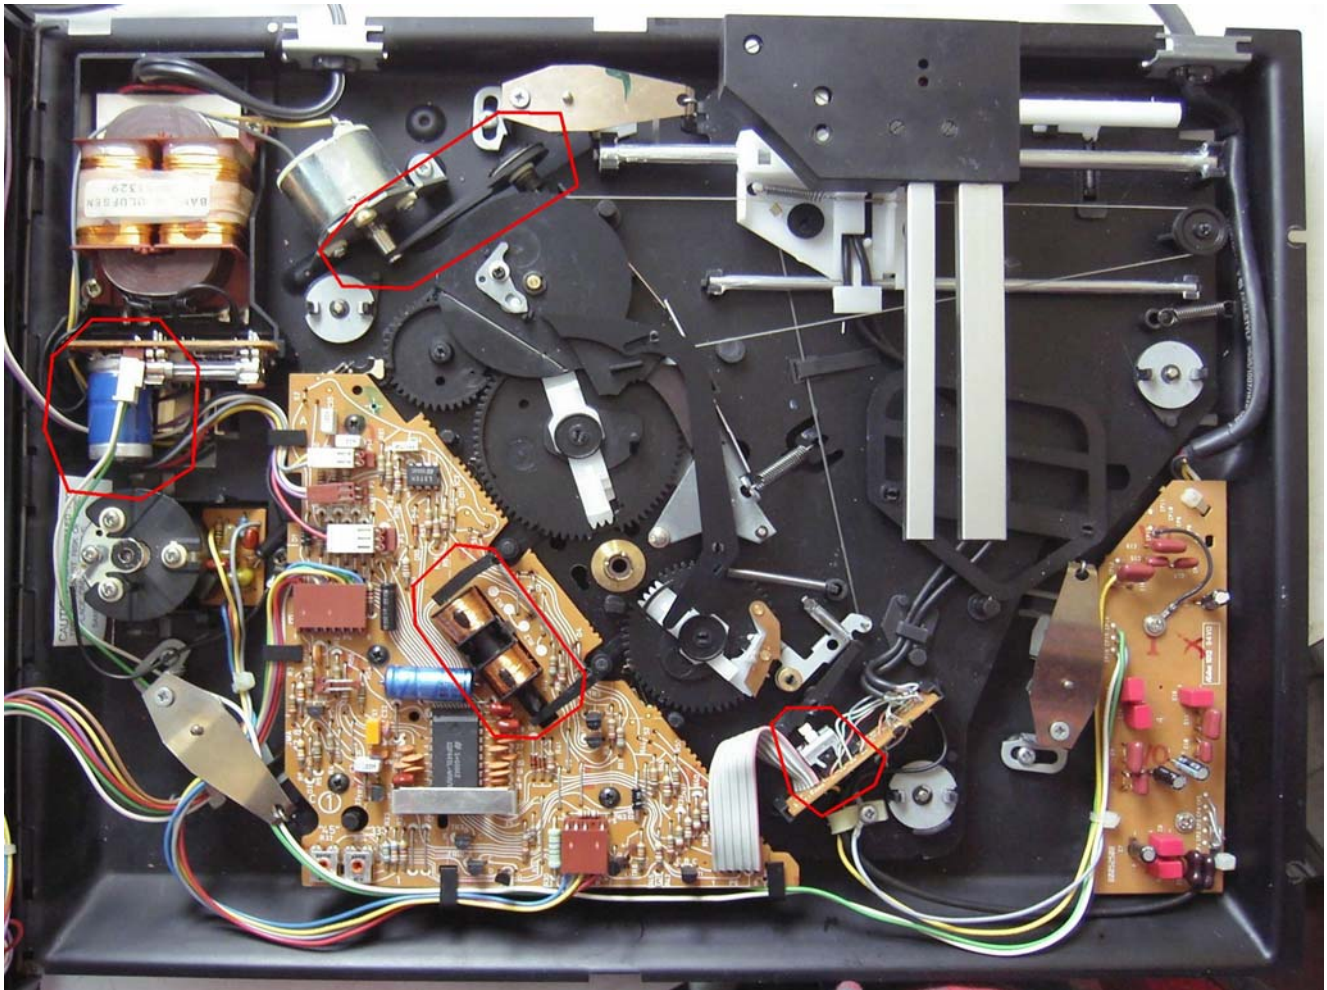
1. Replace the Rubber Drive Belts

You will start to hear wow-and-flutter when the belt starts to slip and is no longer able to maintain correct speed consistently. There are 2 belts – a large flat one for the turntable, and a smaller one on the logic mechanism.

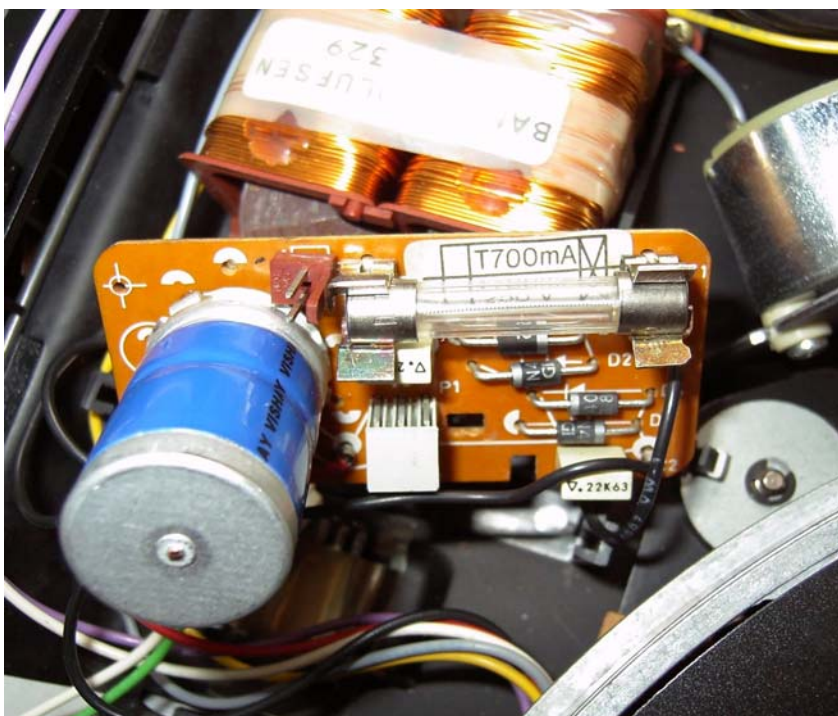
3. Power Supply PCB Modification

The 4 diodes making up the Full-wave Bridge Rectifier are clearly visible. These are regular 1N4002 diodes, and may be replaced with Vishay 11DQ10 Schottky units for improved stability.

The Large Snap-in 1000uF 40V was replaced by an identical Vishay (Philips) AML138 1000uF 40V.

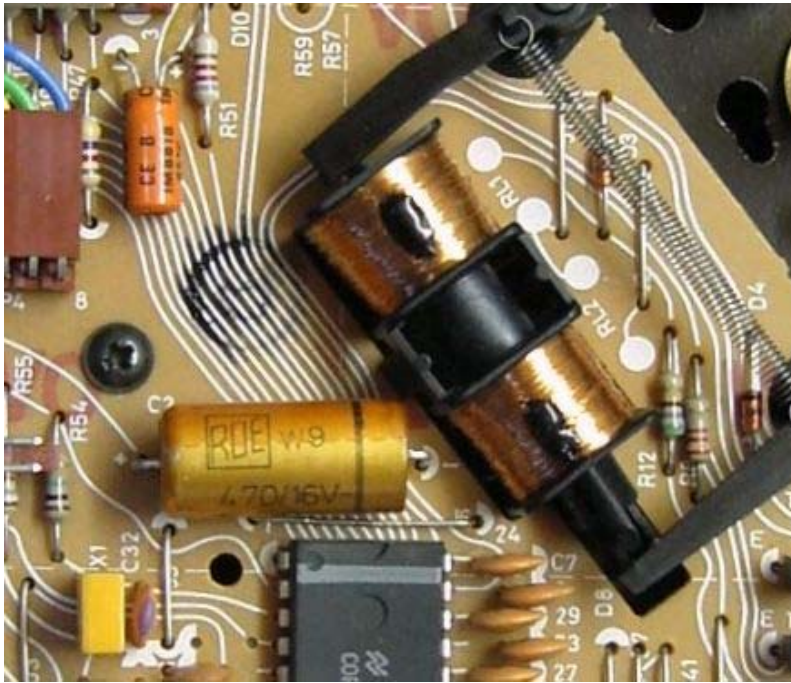
4. Main PCB Modification

There are 2 electrolytic capacitors which need replacement - the large gold axial 470uF 16V in the centre, and the smaller orange 2.2uF 50V above and to the left.

Here I used an axial low-ESR blue Vishay (Philips) 138AML 470uF 50V and a black Panasonic EB 2.2uF 50V - see the new capacitors in the above main picture.

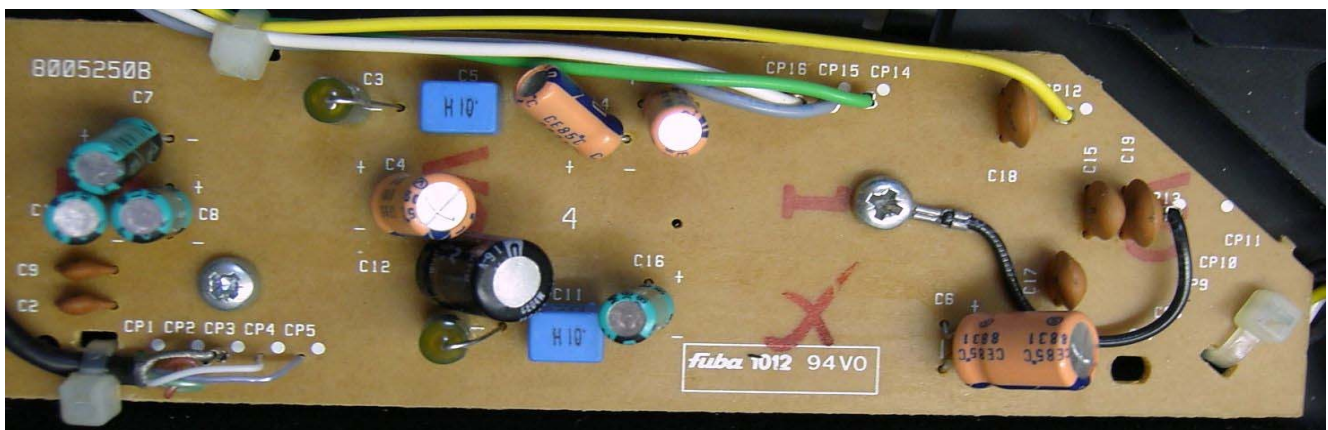
7. RIAA PCB 8005250B or 8005269 Modification

The original components are very mediocre quality – regular ELNA electrolytic capacitors, and standard ceramic capacitors, known for their grainy sound.

It is very easy to modify this high-quality RIAA amplifier. I selected audio-grade capacitors, and replaced the 2 op-amps. You need to be skilled with this operation – the foil-traces are fragile, and SMD components are not forgiving of clumsiness.
