Audio Restoration Project – Repair B&O Bang and Olufsen BeoMaster 5000 Receiver

This applies to all similar type numbers 2321 , 2322 , 2323 , 2324 , 2325 , 2329

Symptoms: This unit was shutting down by itself, when the volume was above 3.0. The sound generally was poor, and sometimes the radio bands would fail, leaving only white noise.

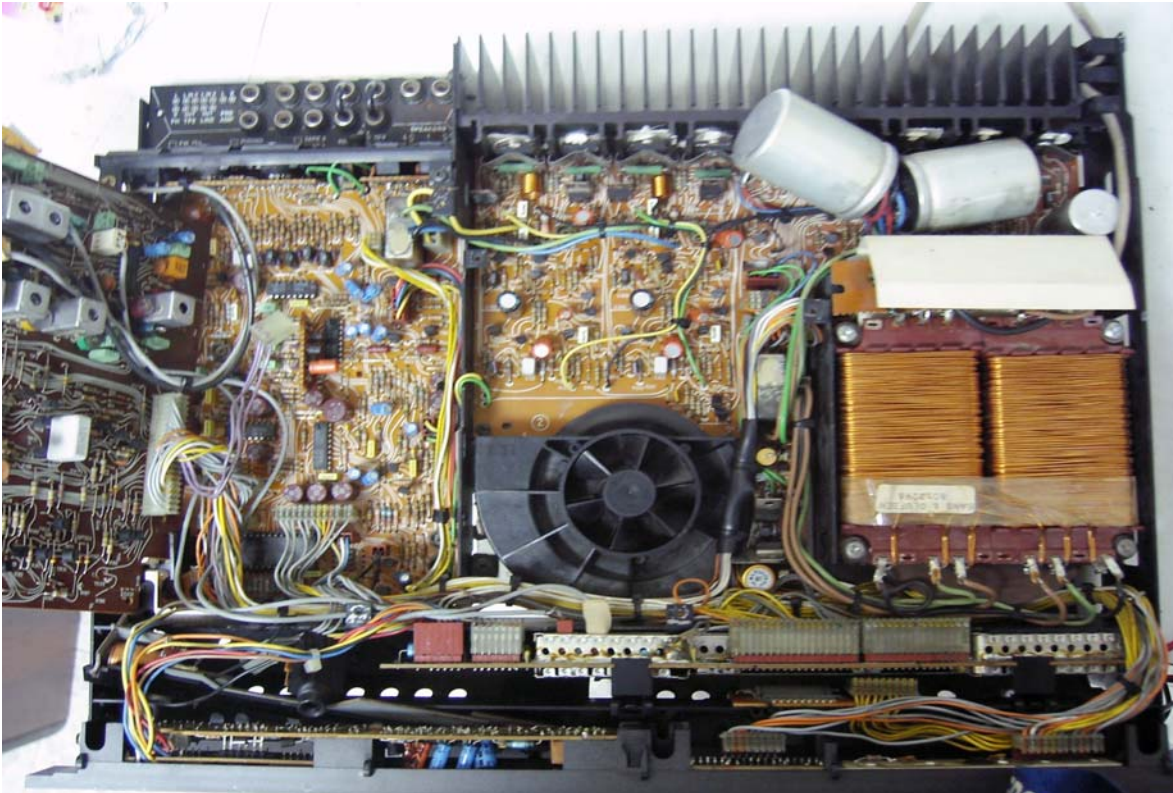
Here is the unit after a compressed air and detergent jetspray cleaning – the unit must be clean before I start work

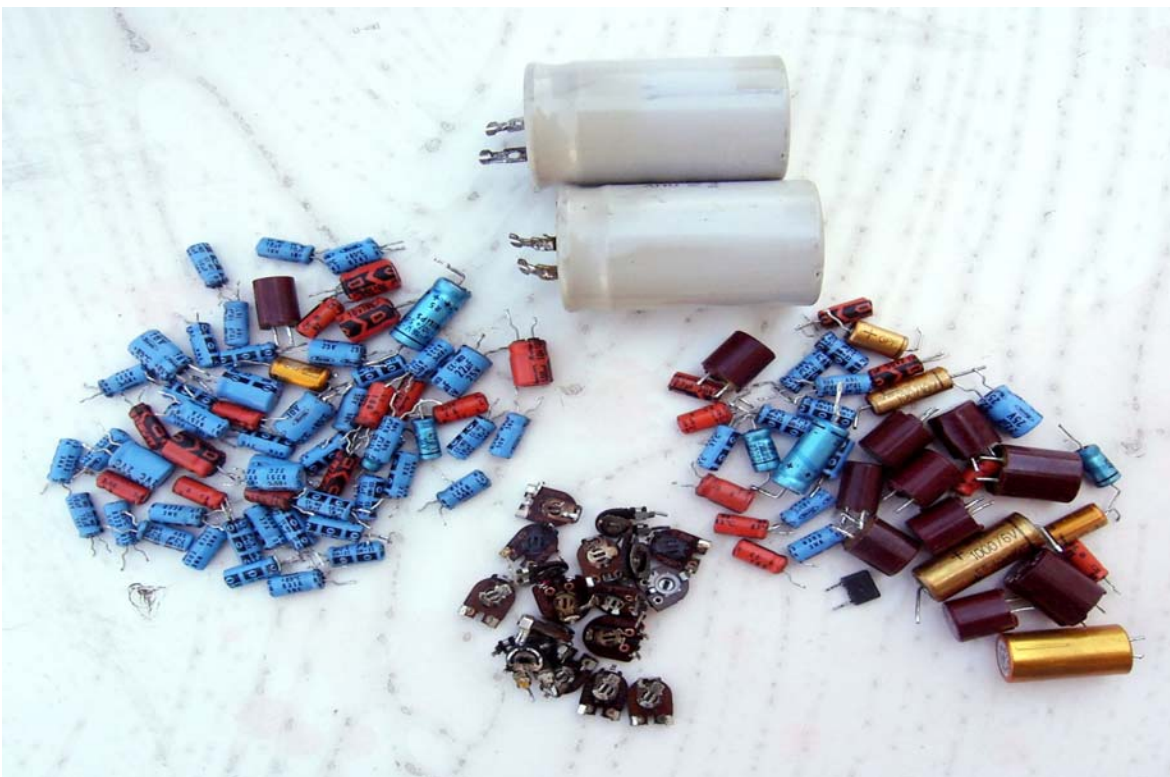
Here are all the capacitors and potentiometers which were removed from the unit

Sometimes techs criticize the fact that these expensive German Roderstein capacitors, which B&O used as original equipment, are no longer functional. I want to remind these chaps that these were excellent capacitors at the time, they lasted well over 10 years in a fully-functional state. We're now at 30 years since manufacture – I think it's pretty reasonable to expect that they are ready for the trashcan.

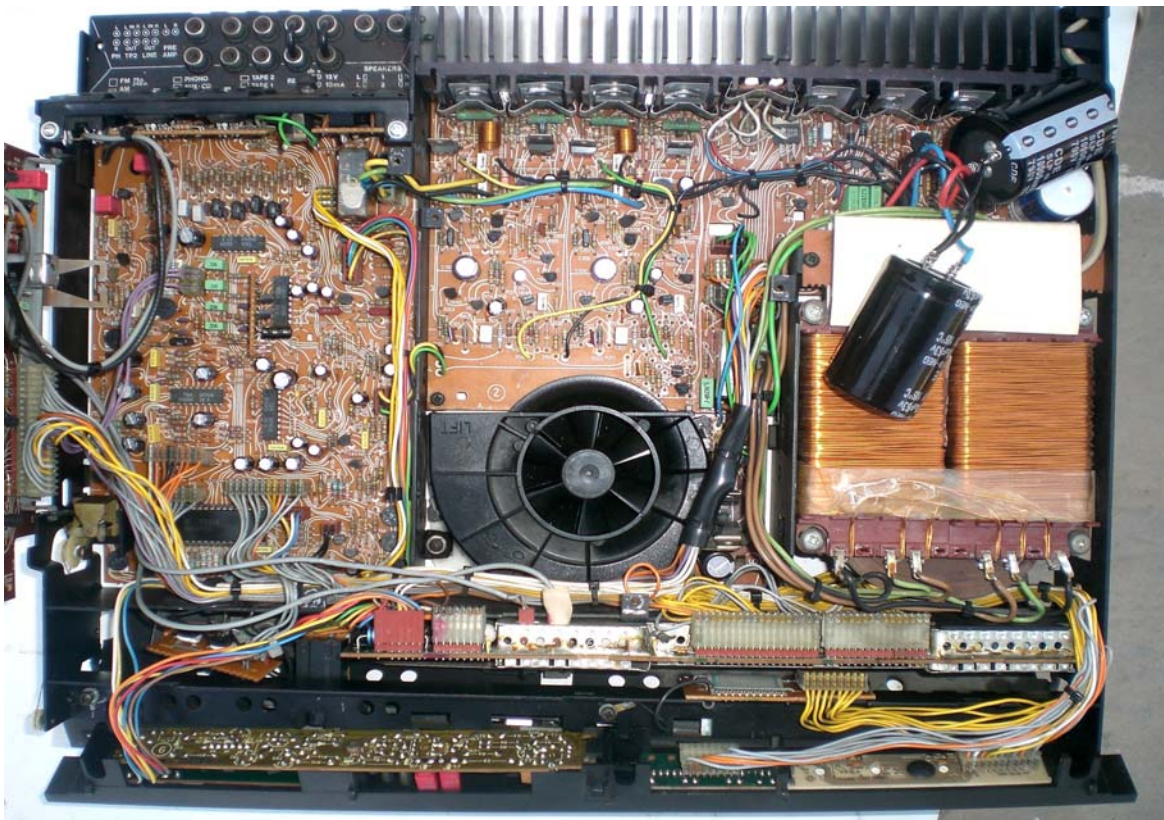
Here is the unit after complete restoration – at the left is the pre-amp PCB; in the center is the power-amp PCB with a temperature-activated cooling-fan; at the right is the power-supply; at the front are the CPU and front-panel control PCB's.

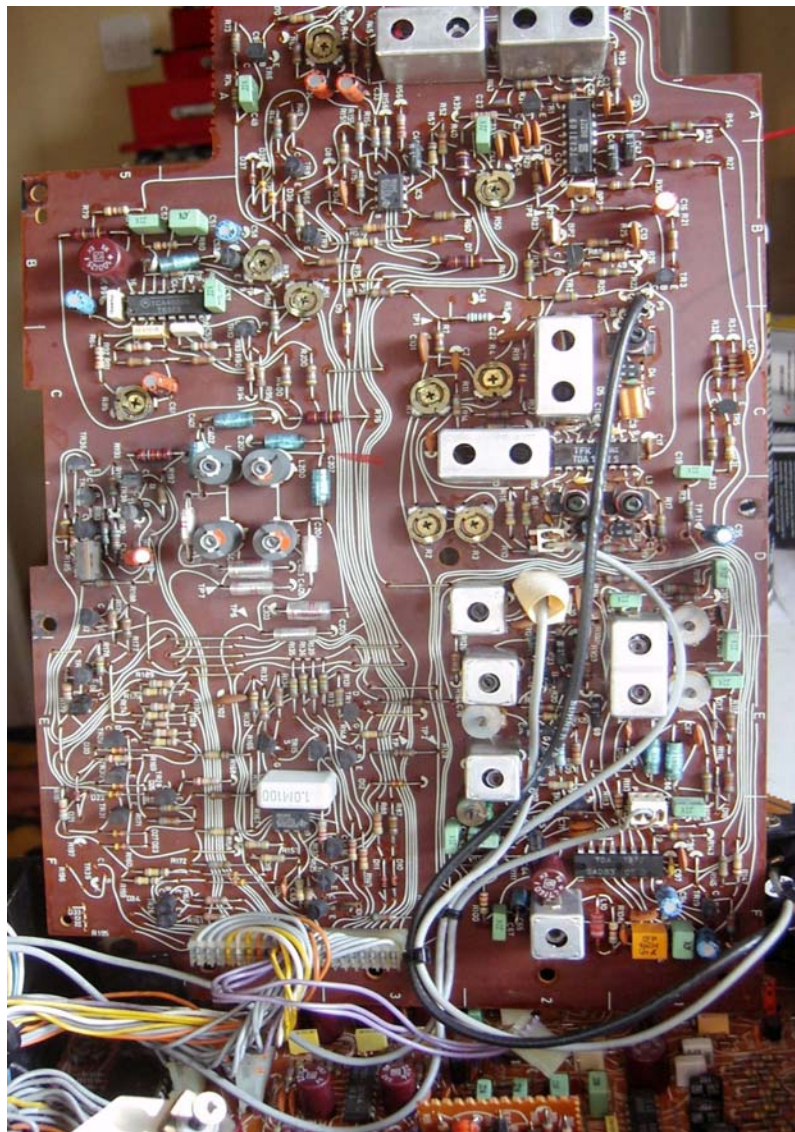
This is the RF and IF PCB.
 Note the oxidized trimming
 Potentiometers.
 All were replaced by Bourns
 3352 Cermet units

This is the RF and IF PCB, after capacitor and trimpot replacement.

During the Tuner Alignment, the Service Manual cautions against adjusting Coil L14, which is factory set.

This coil is shaded in red, under the right-side grey cable.

Alignment was done, using a Tek 2465B oscilloscope, and an ST-1000A signal generator.

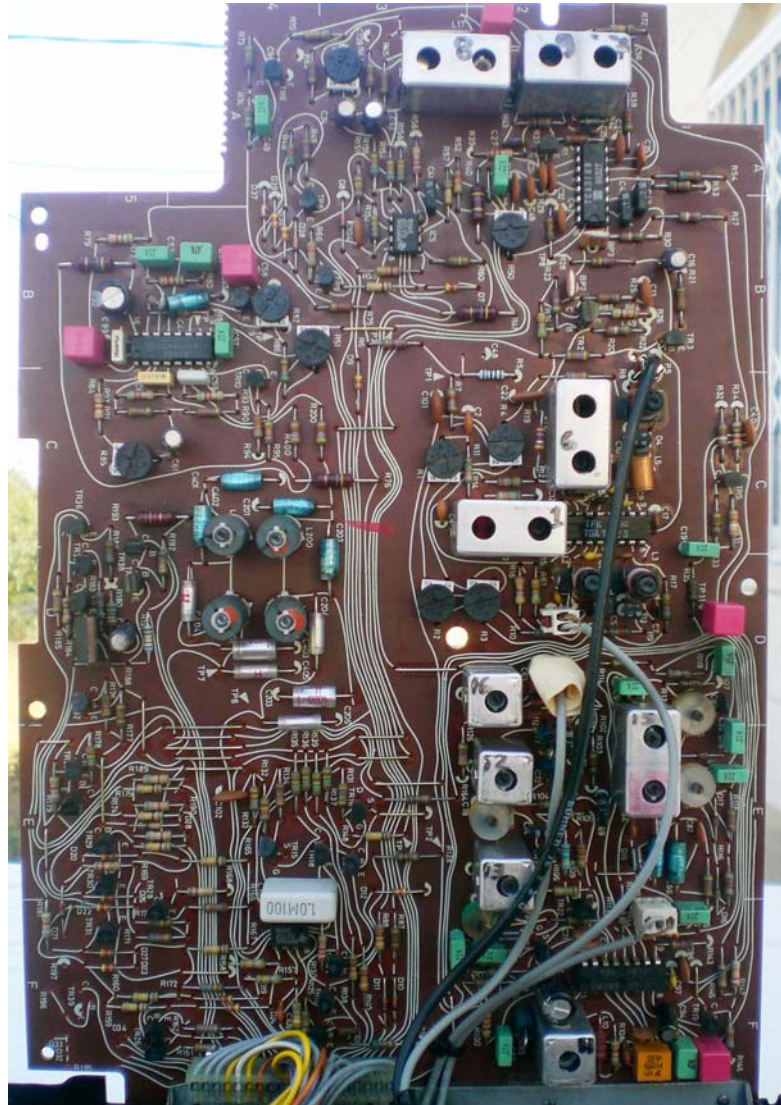
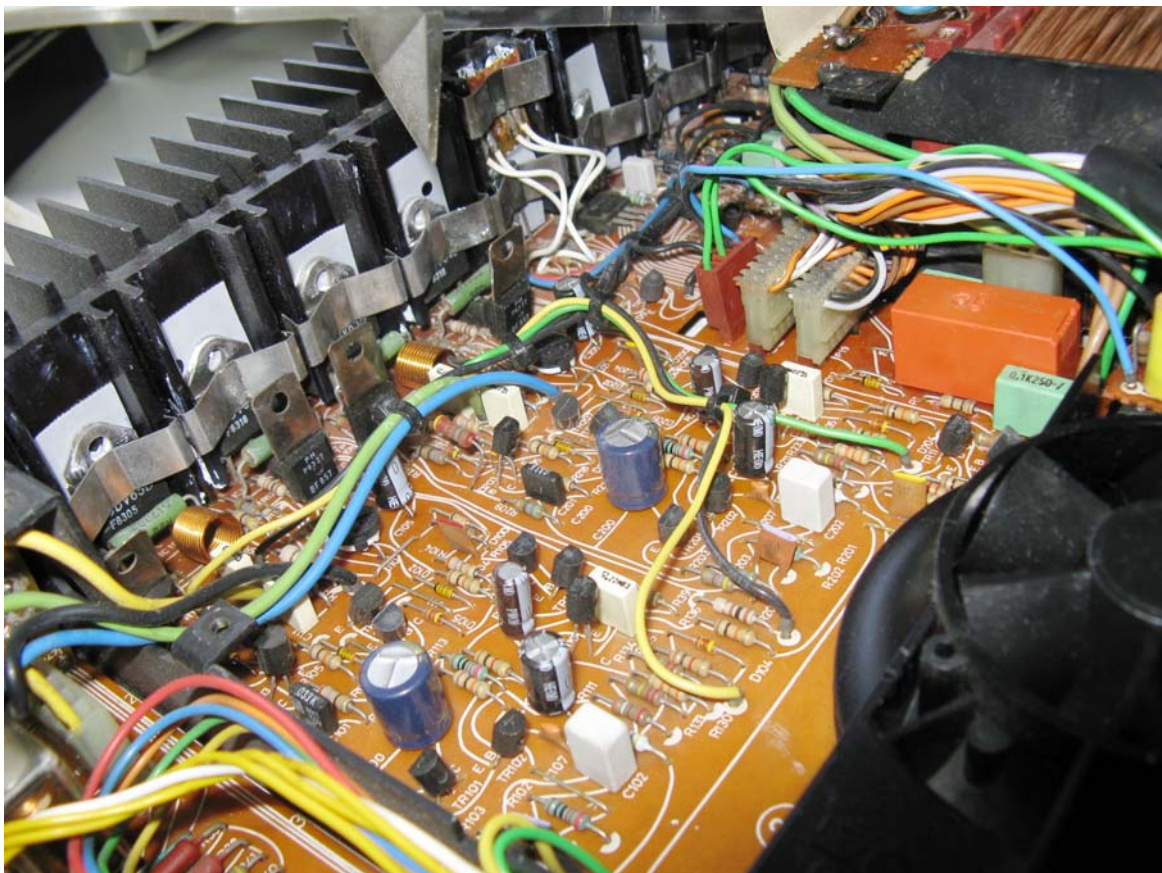
Below is the Power-Amp PCB. Note the new Schrack relay, and new silicon film at the heat-sink of each transistor.

The Bias-Emitter current was adjusted to 11mV to ensure cool amplifier operation

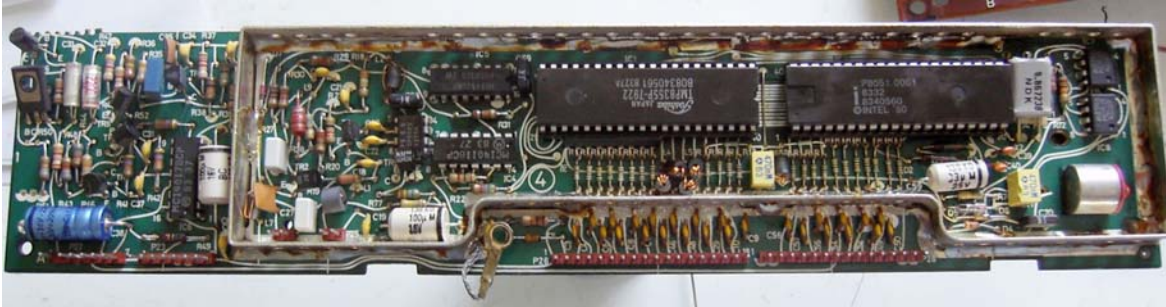
This is the Tuner and Control PCB, with new Vishay 138 Axial capacitors. A 1N4148 diode at the 3V Battery control circuit also required replacement.
