Audio Repair Restoration Project: Klipsch ProMedia Ultra 2.0 Computer Speakers.

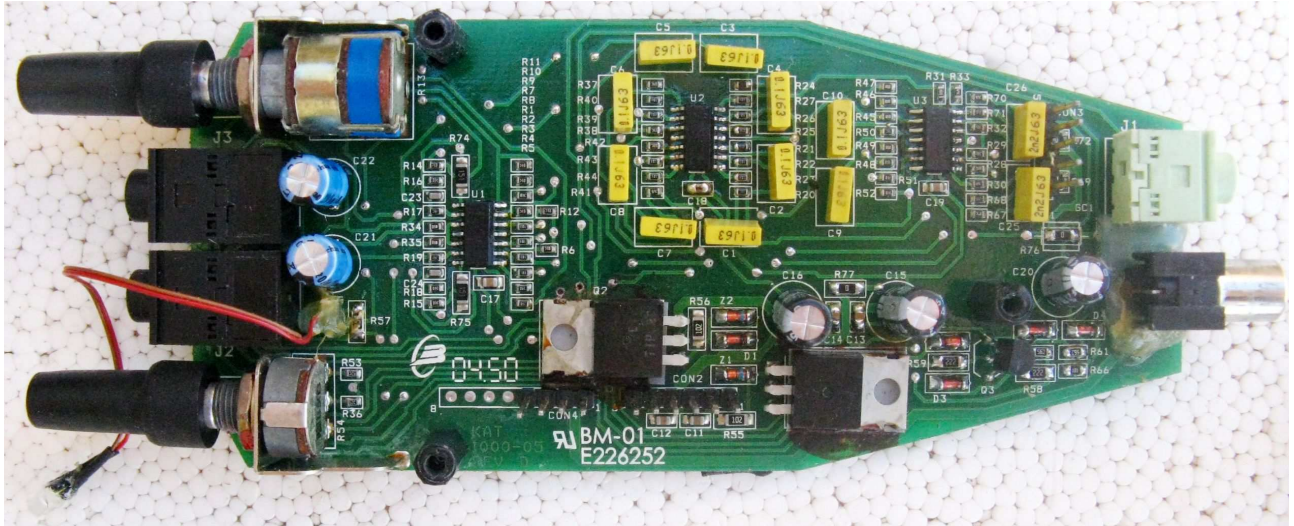
This is NOT at all a user-friendly unit to disassemble, even for a skilled technician. The double-decker PCB's are soldered together via 11 pins, which requires tedious desoldering and separation. Not to mention having to fabricate wiring between the 2 PCB's to facilitate troubleshooting and testing. It may be cheap for production, but it's a pain to repair.

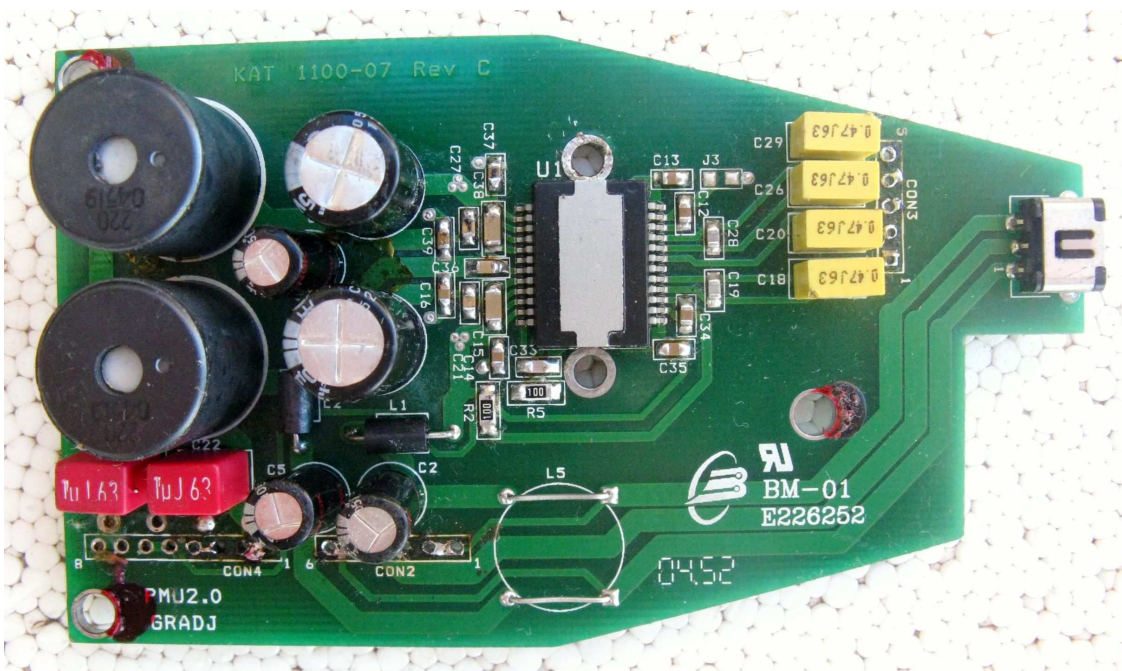
2. Upgrade the Electrolytic Capacitors

My first Go-To solution is checking all the electrolytic capacitors. On this unit, they are made by Capxon and Orient, two well-known players with well-deserved reputations for sub-standard components.

But once again, their ESR tested OK – not great, just OK. So that was not the problem.

However, I decided to replace them anyway with Nichicon HE and KT audio capacitors, to ensure reliability and long-life after the repair.

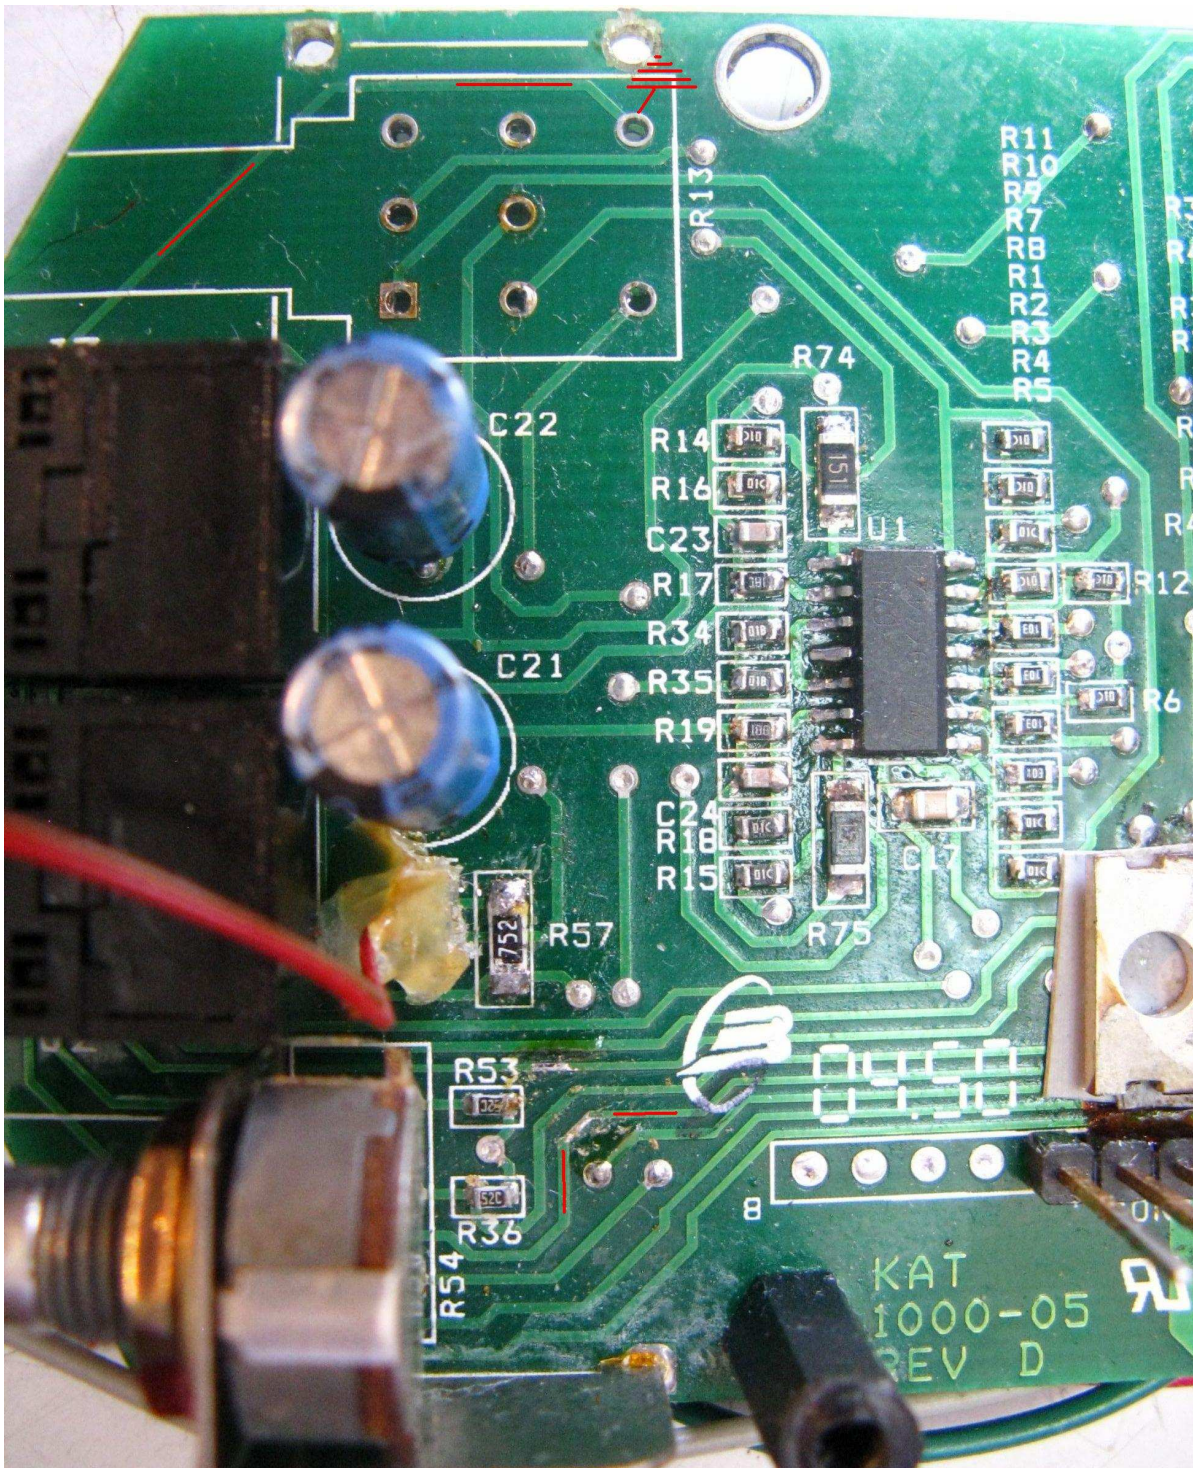
3. Check Power and LED

I had to remove the On/Off/Volume Potentiometer-Switch from the PCB to determine which traces went where, in order to locate any possible problems.

I scratched the green mask off a couple of traces, in order to check continuity, and here I ran into a problem.

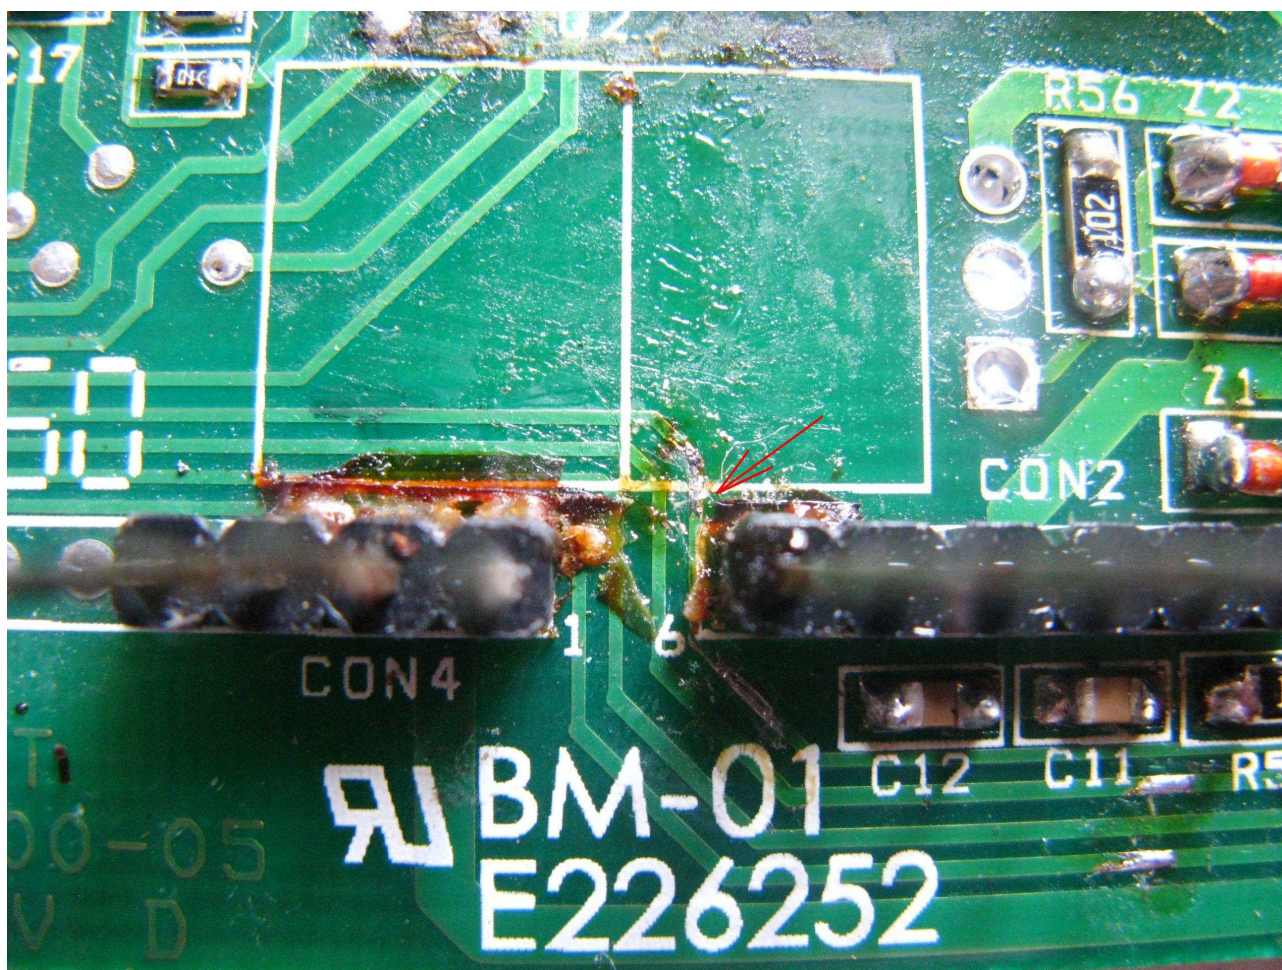
4. Check for Continuity

The On/Off rail disappeared under the TIP32 transistor. So I removed that. I checked for continuity again, and there was none!

Here, as is quite common in Chinese electronic assembly, the factory assemblers had been very liberal with glue to hold down the TIP32. And I'm sure that there were plenty of scratches in the green mask, from less-than-careful assembly.

So we have a well-known and deadly combination for electronic components – Burnt glue (due to the heat of the adjacent TIP32) is conductive and highly corrosive, and it caused a break in that On/Off rail.
