Audio Restoration and LED Upgrade Grundig Satellit 700 Portable Radio

This particular model, with a first-series early-production 6-digit Serial number, was made in Portugal for the British market in the early 1990's, and is a very well-made unit, capable of long-life, with satisfying sound.

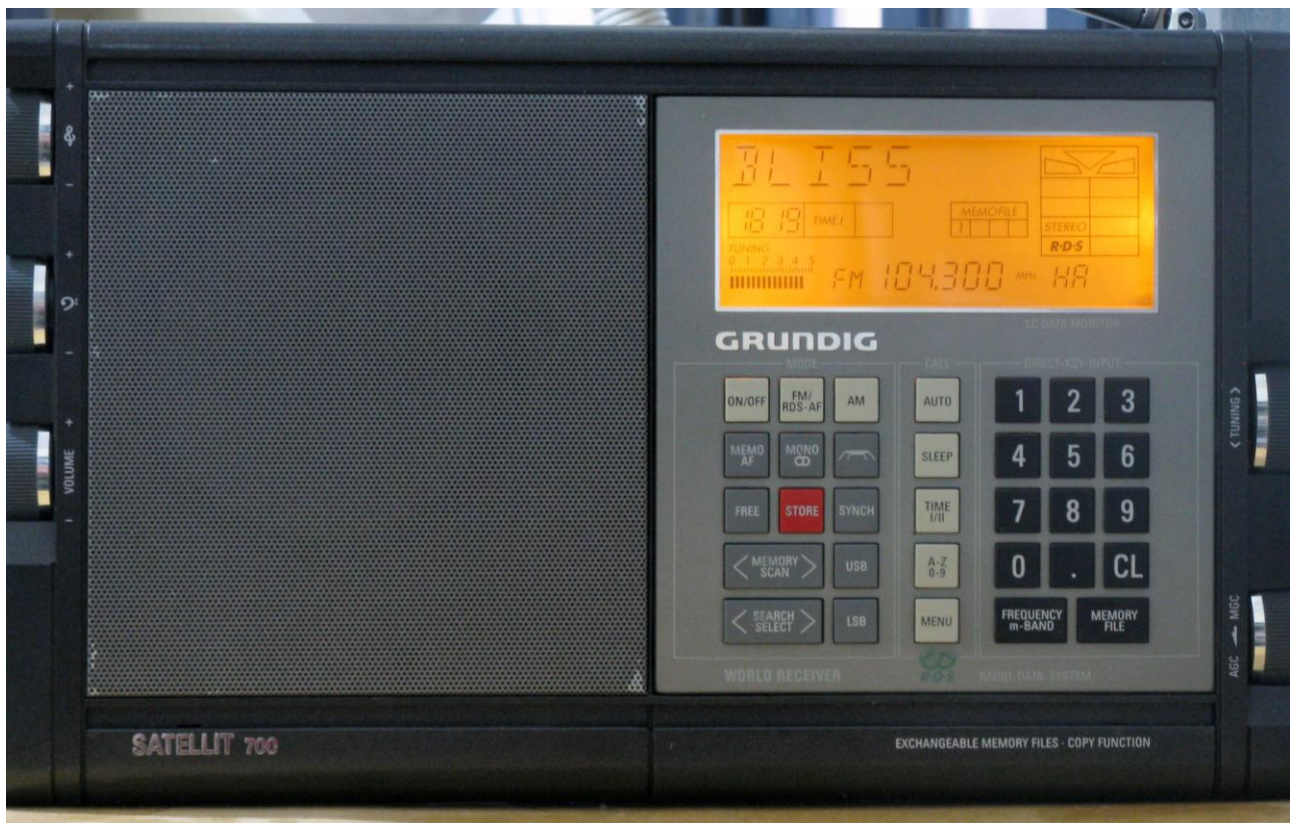
The internal components are of high quality from reputable manufacturers, which is a pleasure to see. There are however, numerous problematic issues, common also to the Satellit 500, with which it shares many components and circuits.

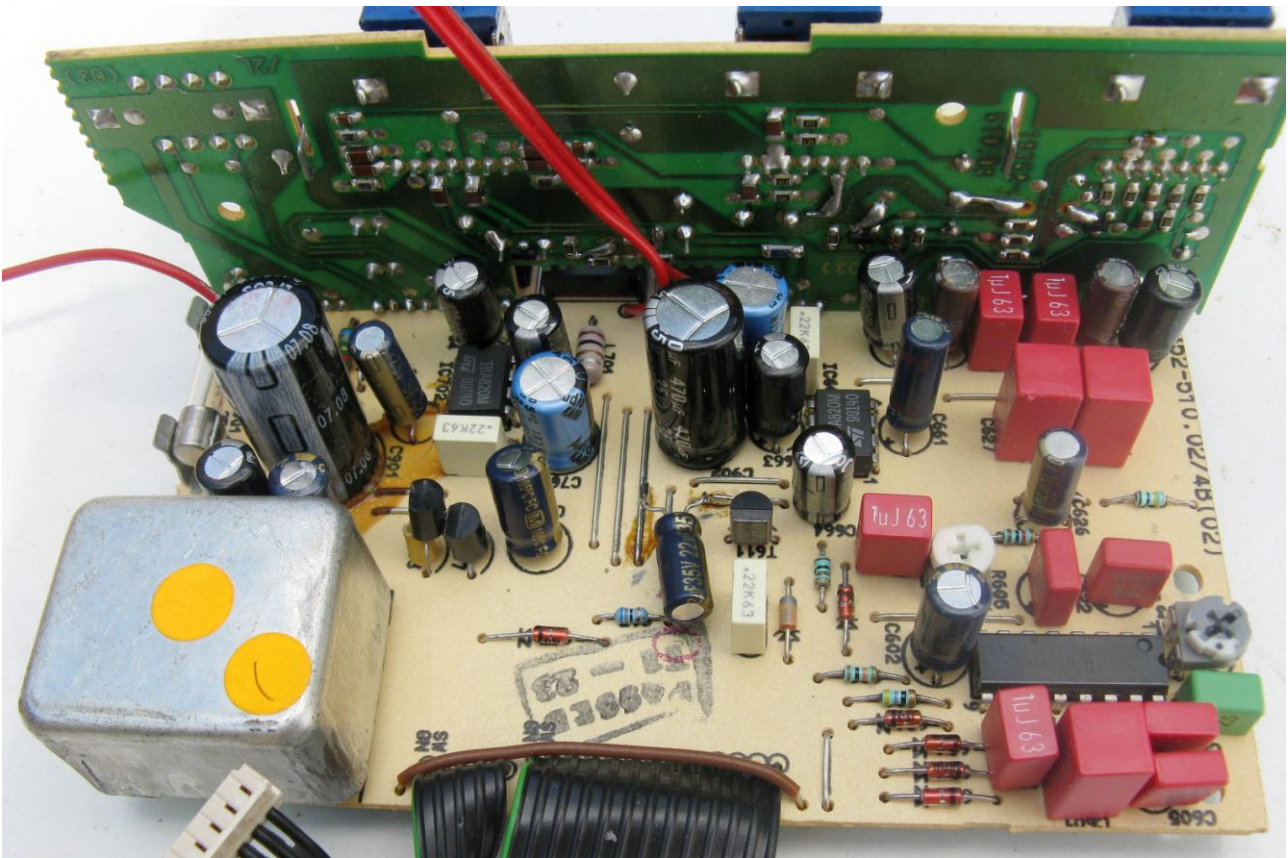
Below are the Tone and Volume potentiometers, with the Wima Audio-Grade Film capacitor upgrades

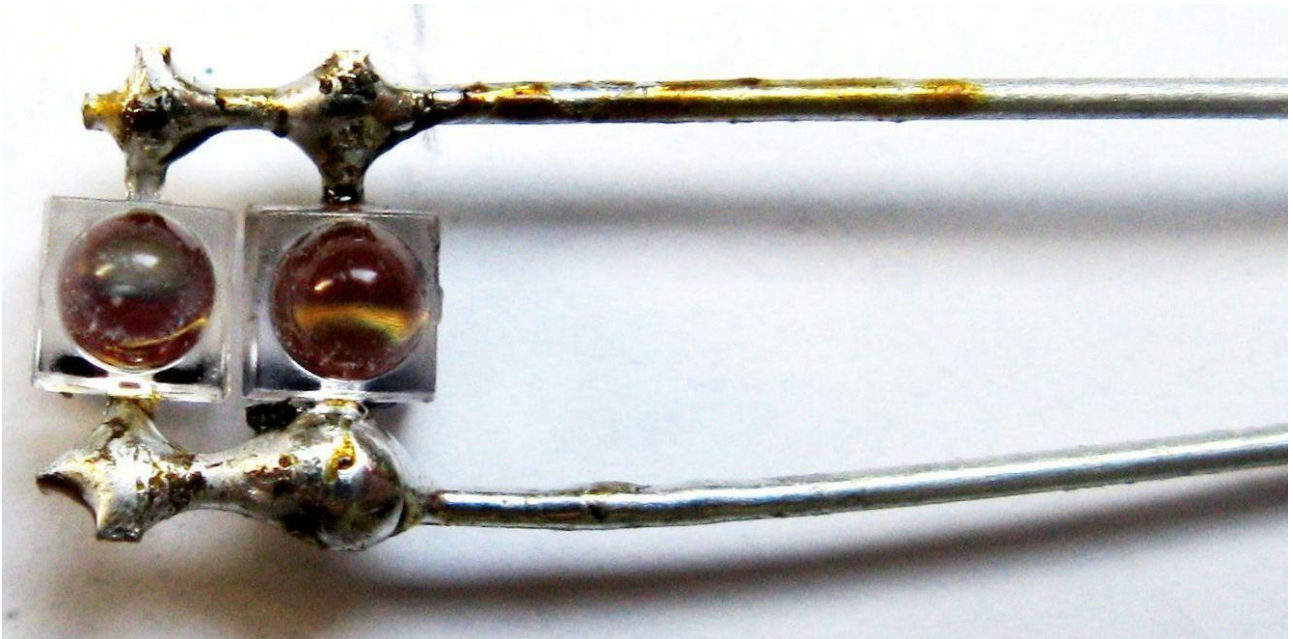
At the LCD Display's Right side, at its rear, the copper trace delivering DC voltage to the LED must be cut, and a 220 Ω resistor soldered in order to bridge the cut trace. This drops the 5VDC circuit voltage to the 1.8VDC required to deliver 14.5mA to the pair of LED's.

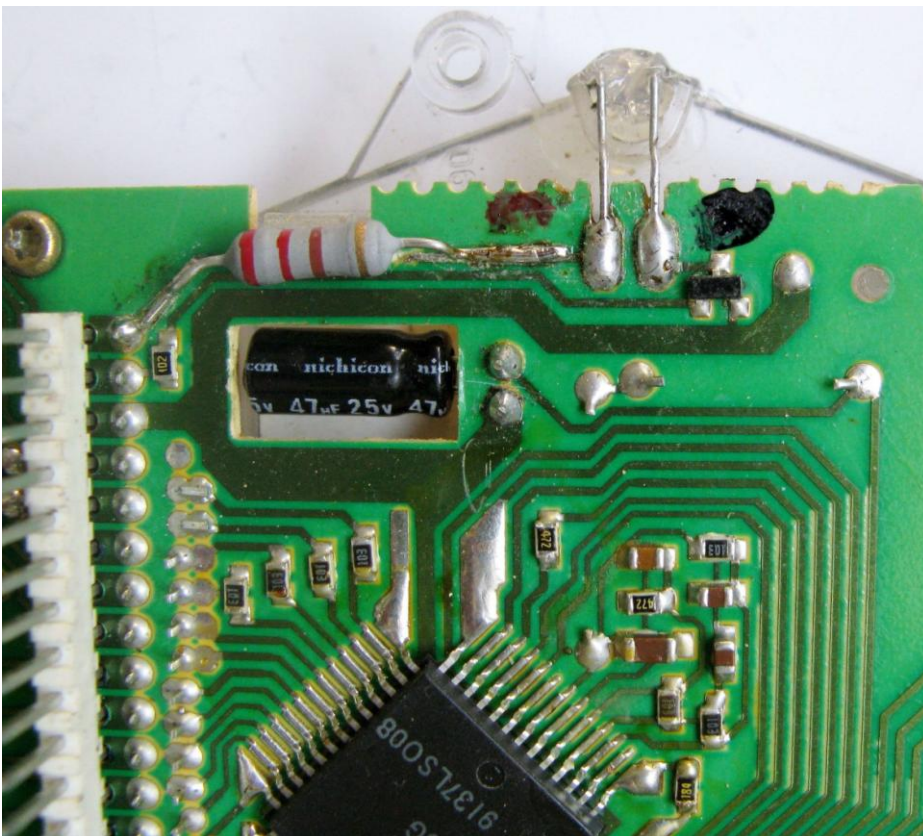
For the LCD's Display's Left side, above the Reset button at the bottom left of the keyboard panel, there is a pair of wire jumpers. One of them must be removed (not important which one), and a 220 Ω resistor installed to restore the power to the Left LED, but now at 1.8VDC.

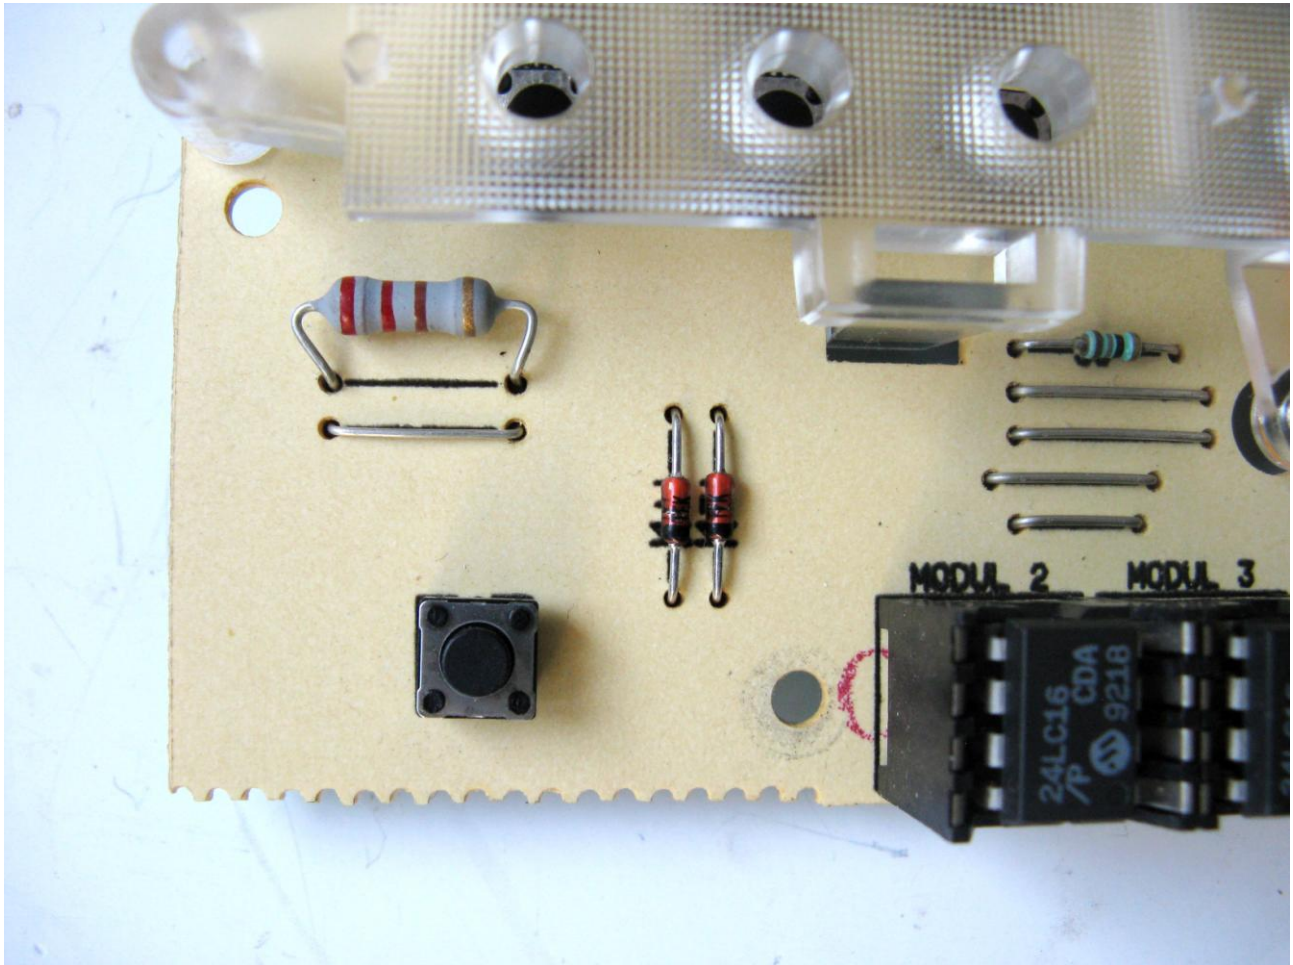
The LED assemblies may now be installed. The leads must be bent to fit correctly.

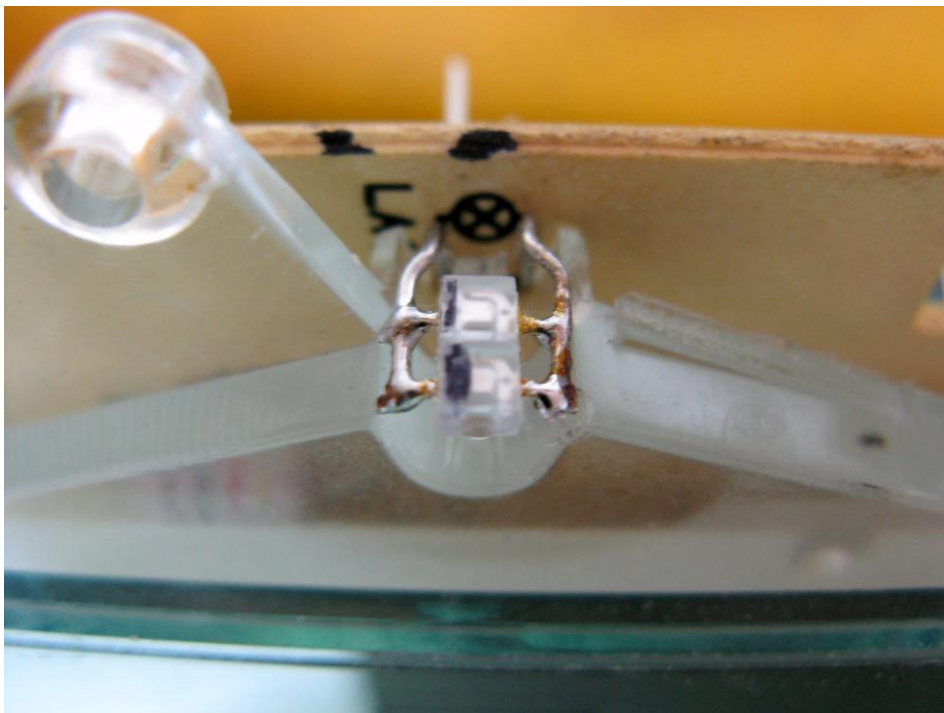
After soldering the leads to the PCB, squirt transparent hot-glue between the LED's and the clear acrylic body of the LCD Display. This assists the lateral dispersion of the LED light, so that the entire LCD Display panel is illuminated evenly.

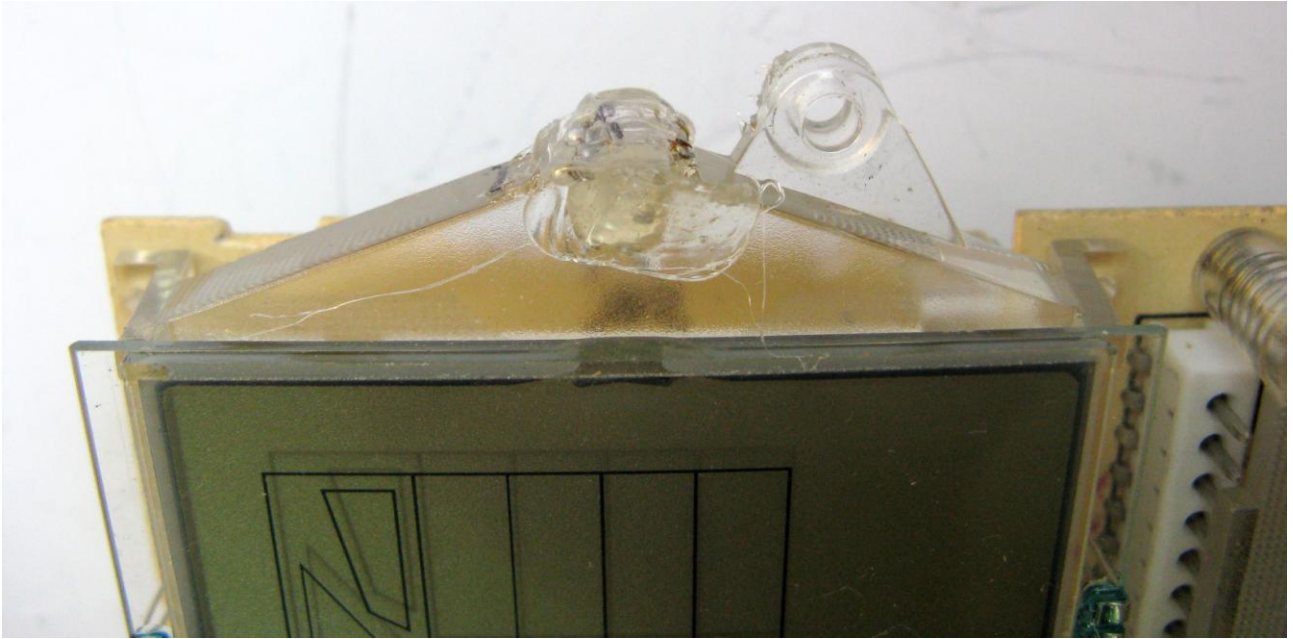
At an easy low-stress current of only 14.5mA, the LED's are very bright, even for daylight, and enhance the contrast and readability substantially.

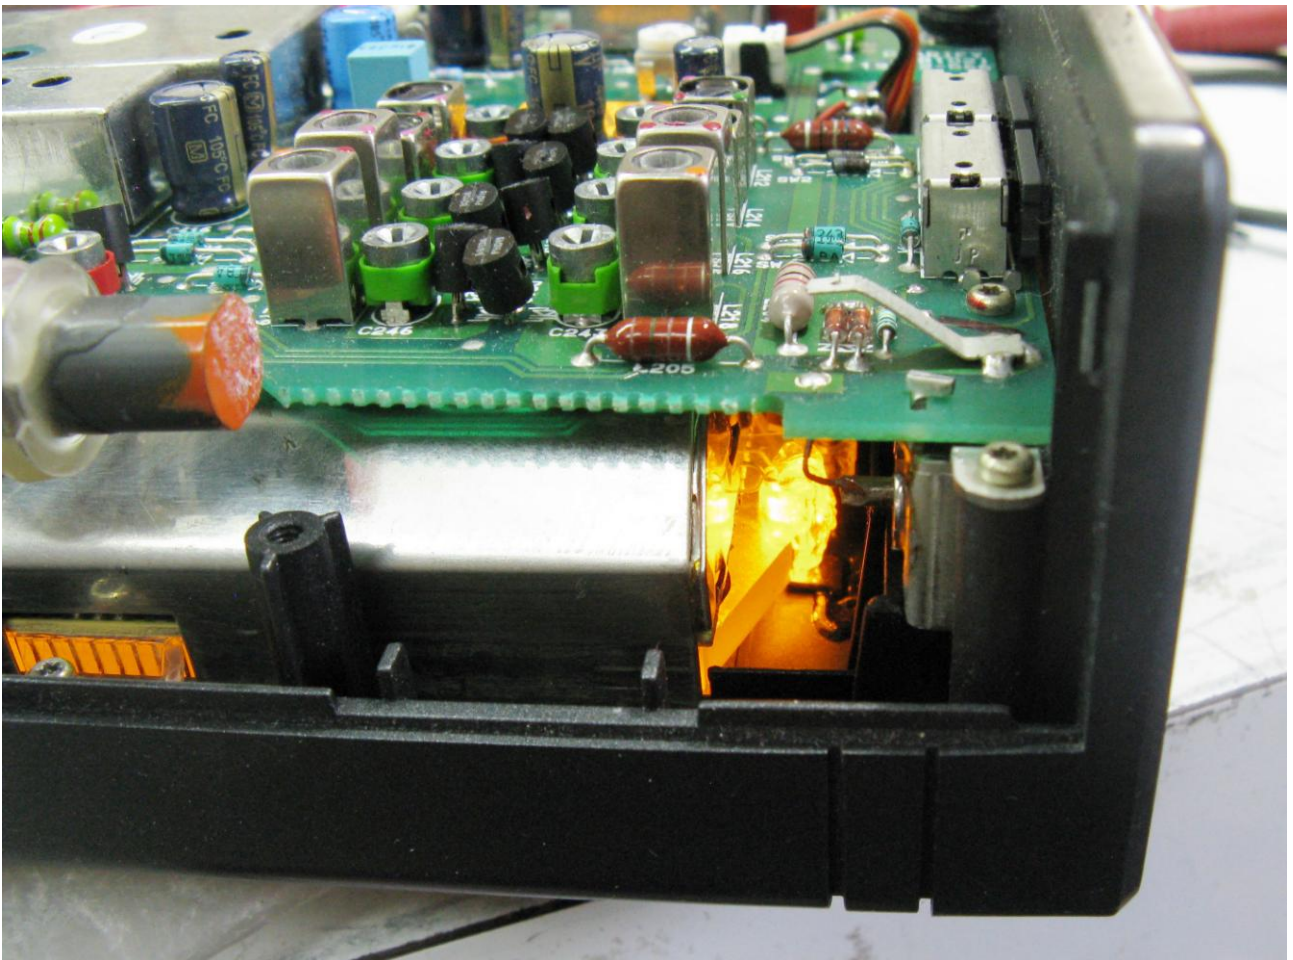
Here, a daylight photo; the DC power is connected at the socket, with the On / Off button at Off. Therefore ONLY the Left LED's are illuminated.
