# Audio Restoration Project – Repair Philips Magnavox Marantz CD650 CDB650 CD Player Modification

This applies to all similar type models using the Philips CDM-2 and CDM-4 transport, commonly combined with the TDA1541 / TDA1541A DAC. These are found in B&O's BeoGram CDX2 , CD3300 , CD3500 , CD4500 , CD5500 , CD6500 , CD7000 , BeoCenter 8000 , 8500 , 9000 , 9300 , and 9500 , and selected models from Acoustic Research , Arcam , Cambridge Audio , Grundig , McIntosh , Mission , Naim , Rotel , SAE , Sherwood , Tandberg , and Tesla.

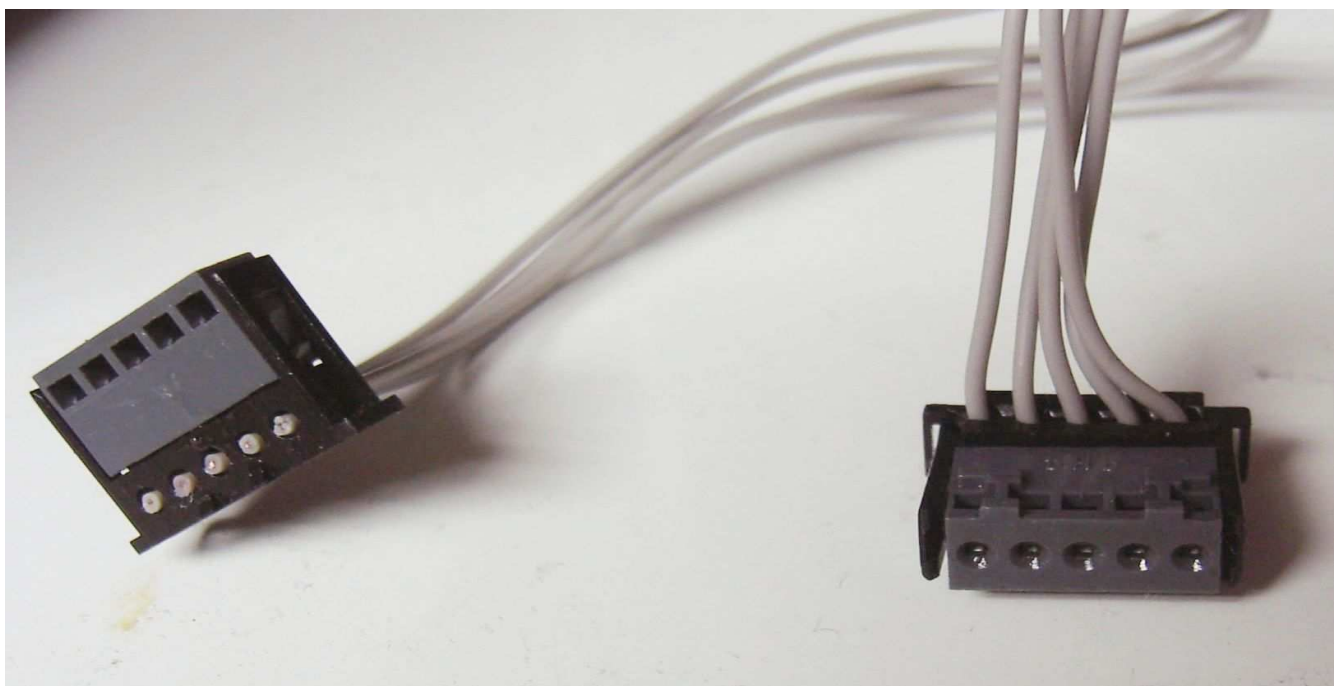
The cause of the random blackouts was traced to the Stocko OEM connectors, whose pincers grip the single-strand copper wire in a knife-cutting action, and over time, the wire simply disconnected from the pincer, destroying the connection.

**These are the original grey single-strand wires, in the Stocko connectors**

Once I discovered this, I simply rewired the entire machine, using Litz multi-strand wiring, which is gripped harmlessly by the pincers. A pity that the Philips designers didn't think about this before production.

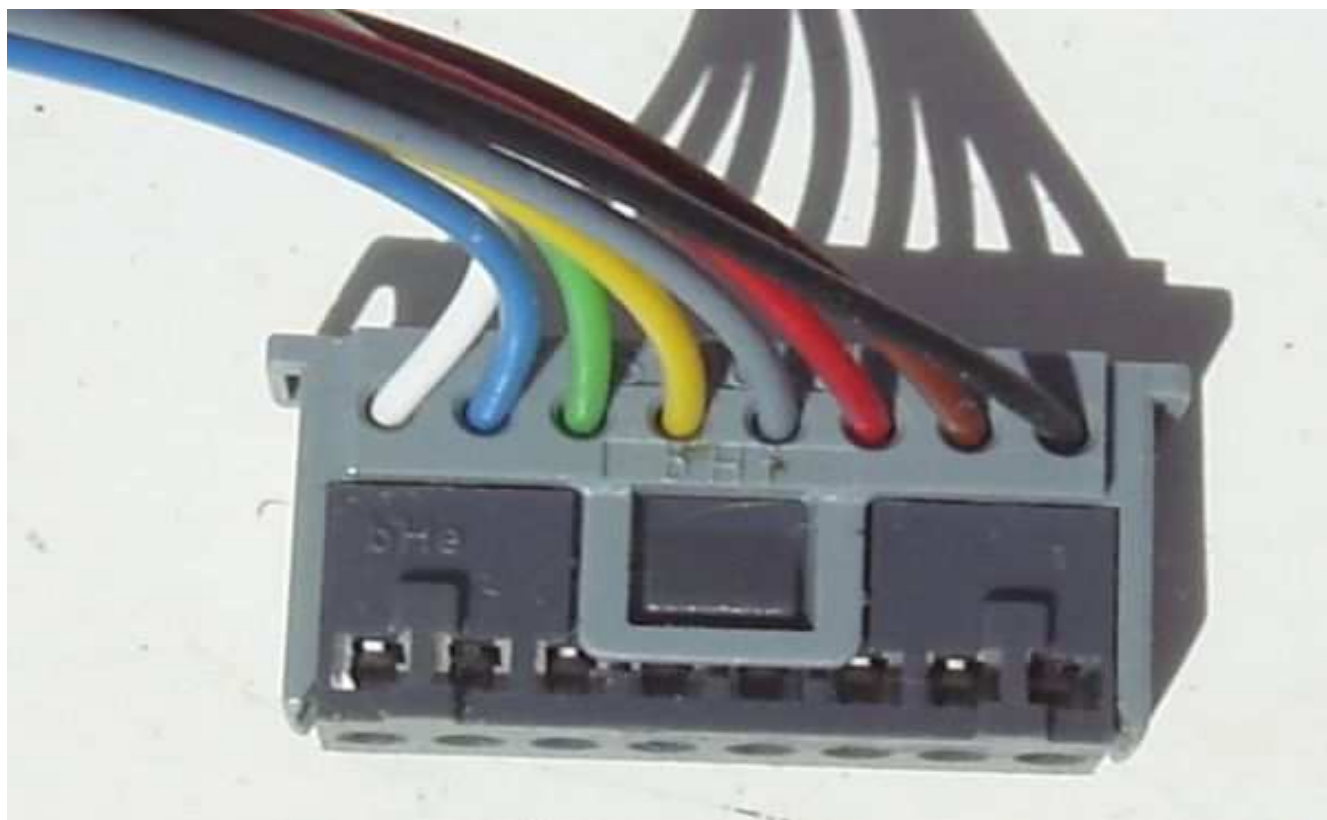
**These are the new coloured Litz multi-strand wire in the Stocko connector**

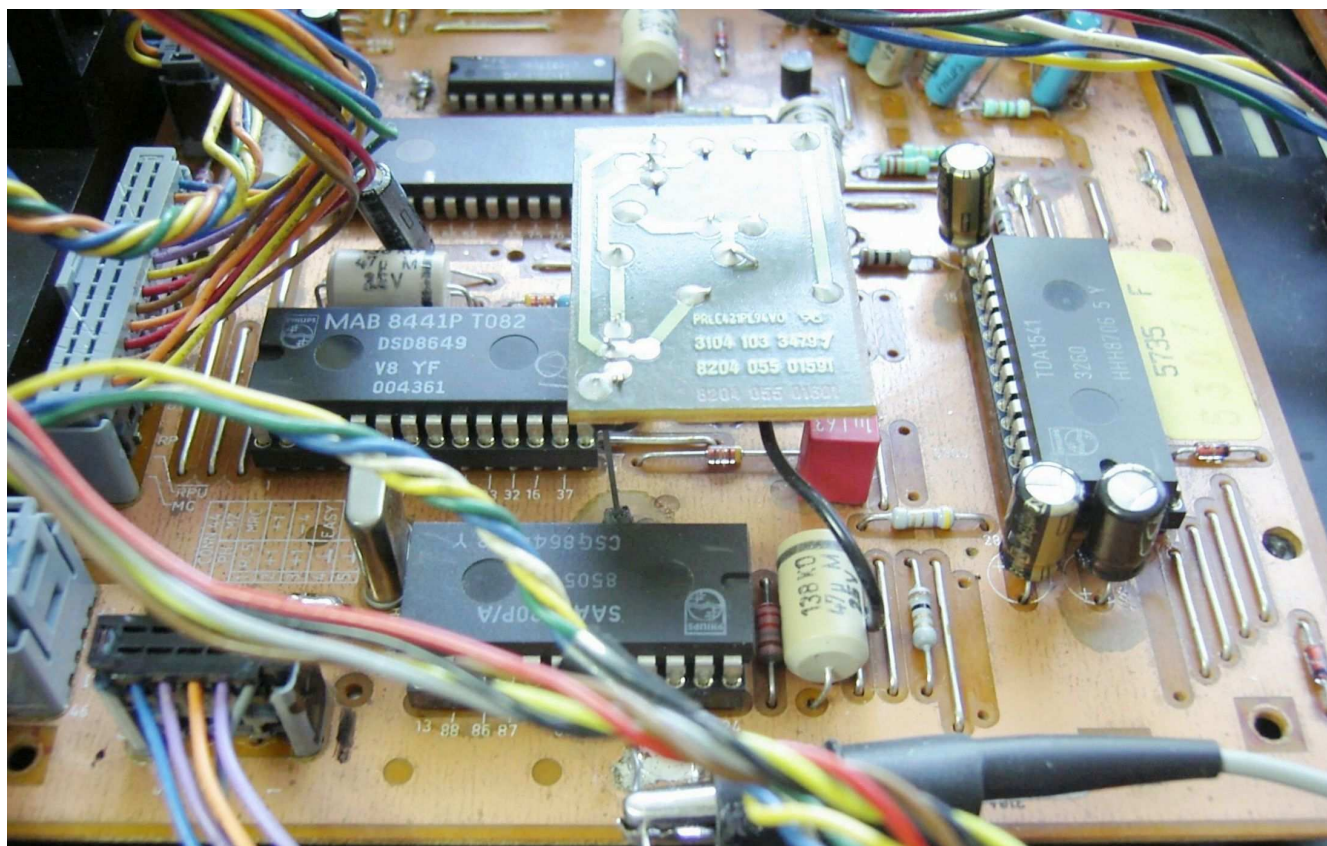
**These are the all the new coloured wiring harnesses, with Litz wire**

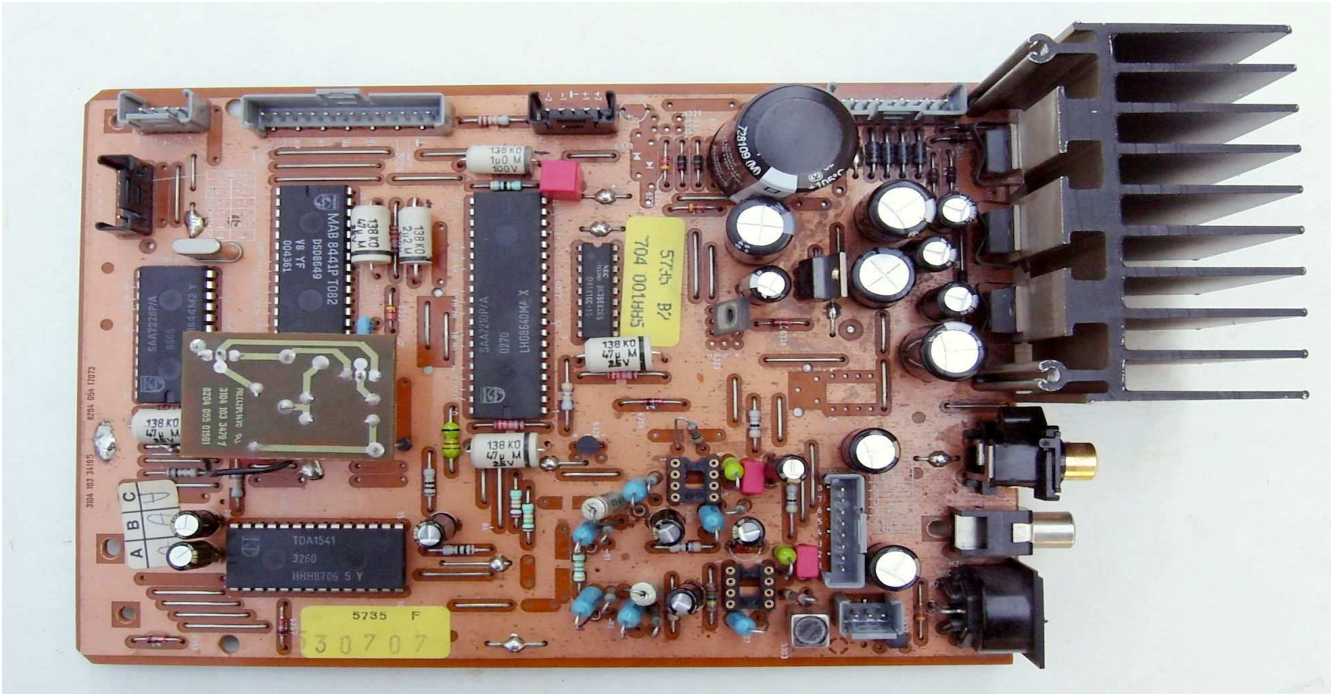
**This is the Main PCB, showing all the new capacitors, and IC sockets**

For working on the main PCB, I planned the work in 5 stages:

1. Replace the 8 bridge-rectifier diodes 6340 – 6347 1N4002 with Vishay 11DQ10 Schottky units.
2. Replace all the PSU electrolytics with high-quality Nichicon HE capacitors of equal capacitance, except for the main 6800uF PSU decoupling cap 2396, which I replaced with a 10,000uF Panasonic TSHA unit. I am not a fan of willy-nilly increasing capacitance values in a circuit, unless there is a very good reason to do so. Transformer overload and damage can very likely occur. I much prefer using very-high-quality capacitors instead, which certainly justify themselves by a much more stable current flow.

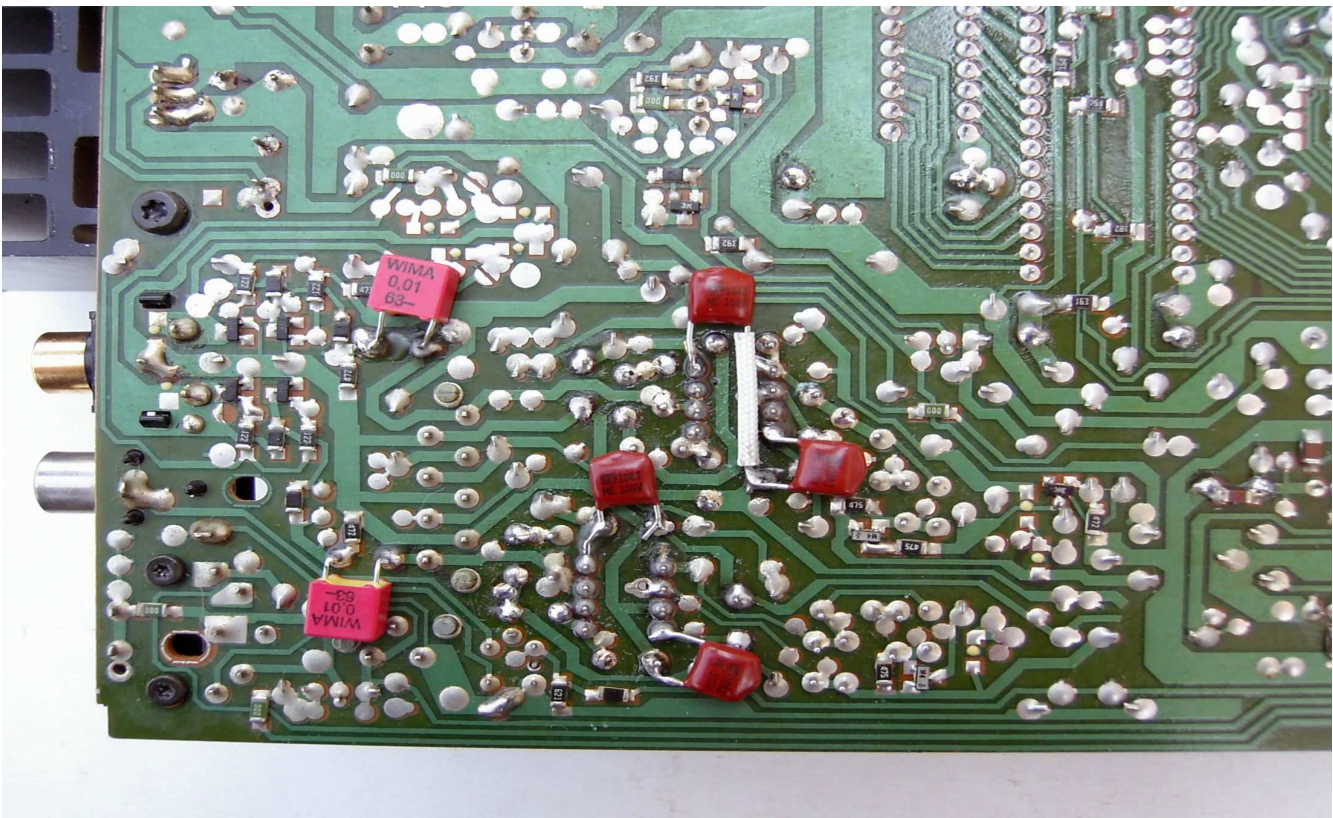
**This is the Main PCB underside, showing the bypass capacitors on the signal coupling capacitors, and on the OpAmp Power Supply circuits**

3. Replace the signal path area capacitors with Panasonic FM and grey Vishay 138 axial electrolytics of equal value. Replace 4 small value electrolytics with red Wima MKS2 film units. Do not touch the original polystyrene axial capacitors, visible around the OpAmp IC sockets.
4. Install sockets for all the IC's – more fun later.

5. On the underside of the PCB, bypass the NE5532 OpAmp's with Panasonic 0.1uF film caps as follows: Power Supply + (Pin 8) to Ground, Power Supply - (Pin 4) to Ground. Bypass the 220uF signal coupling caps 2366 and 2367 with 10nF film caps.

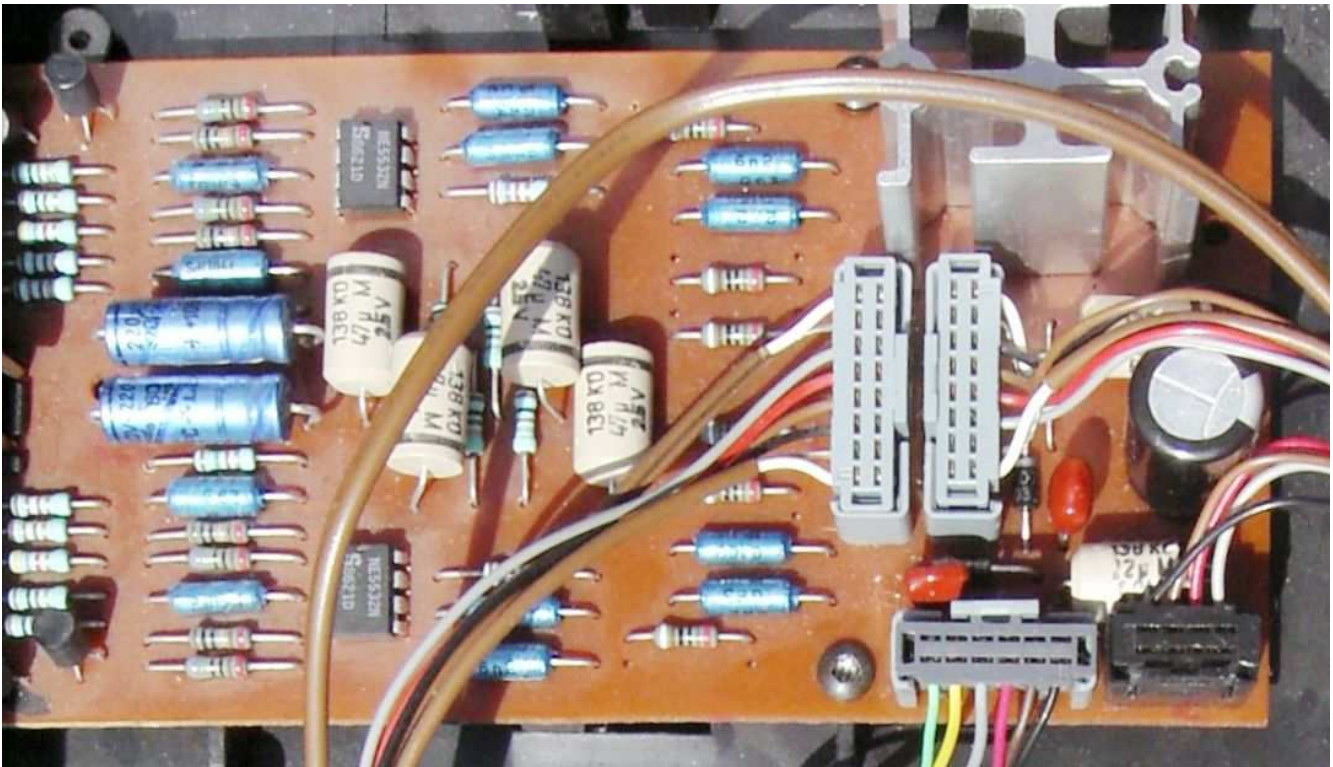
This is the Filter PCB, at the left is the Analogue Filter circuit, and completely separate at the right, is the Power Supply circuit which supplies 32VDC to the Display Panel

On the filter PCB, all electrolytics were changed to grey and blue Vishay 138 axial units. Not really intending to use this analogue output, I left the NE5532 opamps alone.  
In the Display PSU, I changed the main decoupling cap 2922 to a Panasonic EB 470uF unit, and replaced the 1/2 bridge diode bypass ceramic caps 2920 and 2921 with 22nF Panasonic film caps. This PSU circuit uses a 78M24CT regulator, which is bumped up by an 8V Zener diode, to attain the desired 32VDC. So to prevent regulator failure (a common occurrence), the current flow should be very stable, and that requires using high-quality capacitors.

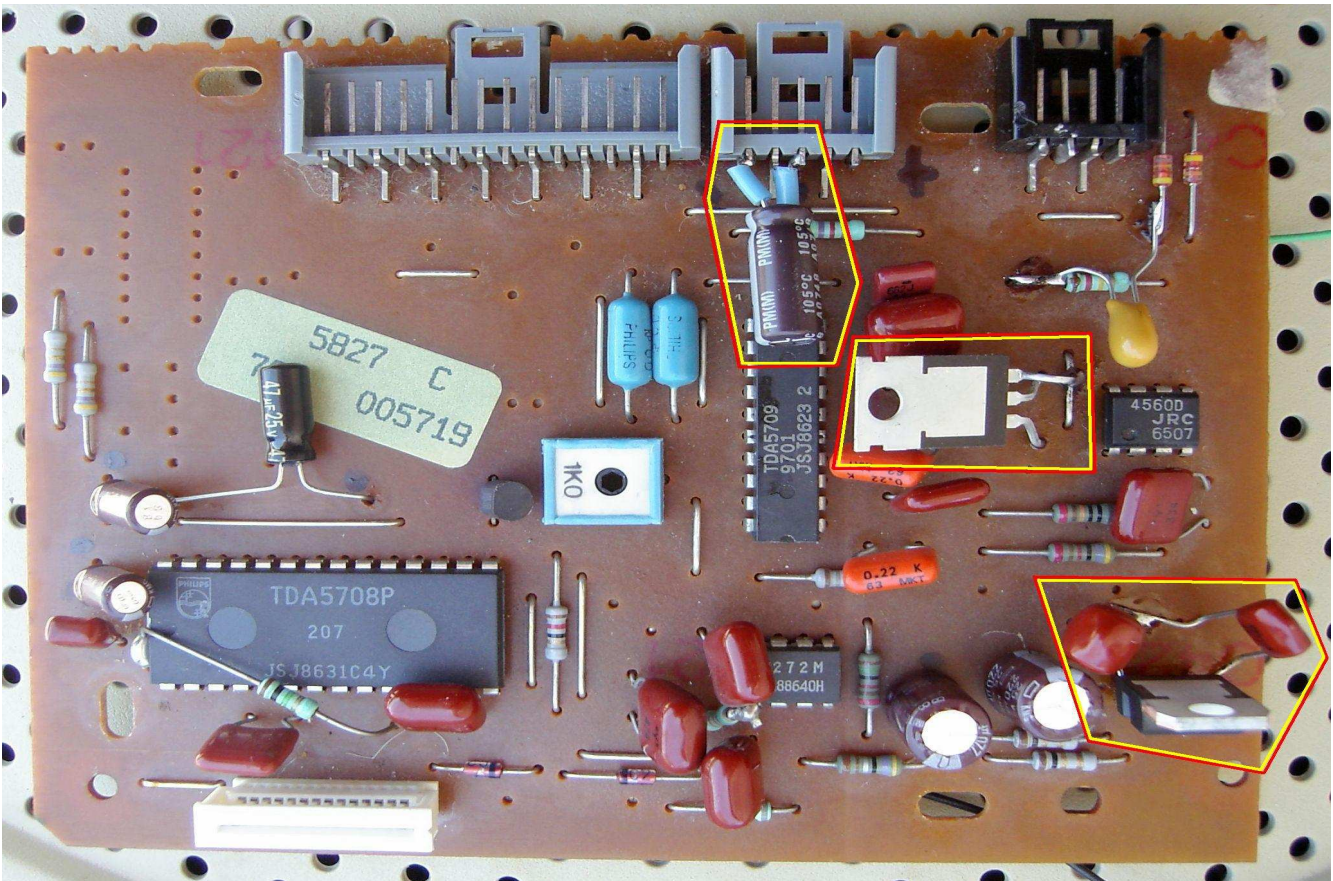
This is the CDM-2 Laser PCB upper-side, showing all the new capacitors, and the Voltage Regulators to stabilize the input voltage

Capacitor C2103 33uF is a known troublemaker, and replacing this with a 47uF 25V unit usually cures all non-laser related ills in this area. For many years in the B&O technical community, we found that unless it was replaced by a Vishay Philips 138 axial capacitor, the circuit would remain dead, but I am now pleased to report that also a Panasonic FM radial capacitor is electrically quite suitable.

All the electrolytic capacitors (except for 2103) are Nichicon PM, but PW or HE are also quite suitable here.

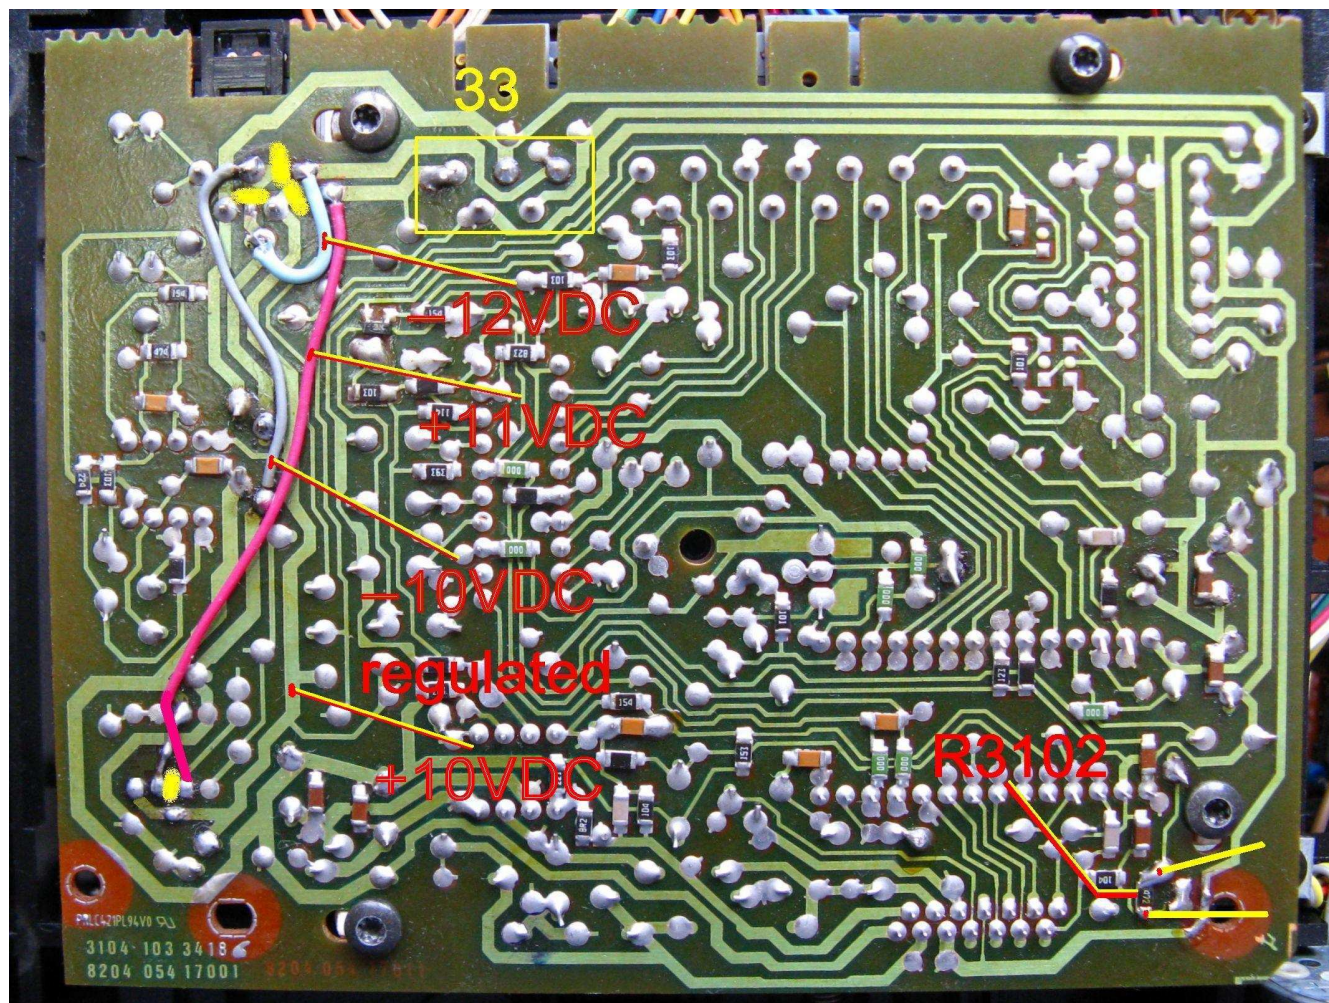
This is the CDM-2 Laser PCB underside, showing the wiring changes necessary to accommodate the new regulators. The 4 Orange marks show where circuit traces have been cut. Do not attempt this mod, unless you fully understand the circuit requirements – you may damage the circuit beyond repair.

The power entry point is at Block 33; Pin 1 is +11VDC and Pin 5 is -12VDC. The objective is to regulate these 2 unregulated voltages at + and – 10VDC respectively. I used an L78S10C, and a LM7910C.

I located these 2 IC's on empty areas of the PCB, which already had solder points for the necessary circuits, without needing to do too much surgery. The L78S10C (with its two film capacitors) is at the bottom corner, and the LM7910C is in the middle of the PCB.

At Block 33 Pin 1 (-12VDC), I added a Nichicon PM 100uF 25V capacitor, with the –ve lead polarity on Pin 1.

The Light-blue wire is -12VDC unregulated; the Purple wire is +11VDC unregulated; the Grey wire is -10VDC regulated, and the remaining trace is +10VDC regulated.

The output of these two Regulator IC's is routed on this PCB to the Focus Drive OpAmp, and also goes to Block 36 – the Turntable Motor Control circuit.

Insert a CD and select PLAY. The 1Kohm potentiometer R3106 at the center of the PCB, is adjusted through the bottom hole in the PCB, to provide a reading of 50mV, which is measured across R3102. I soldered two wires (marked yellow in the above picture) to R3102, and routed them out of the CD player to my Multimeter. The adjustment is very sensitive, and I was quite happy with 50.7mV.

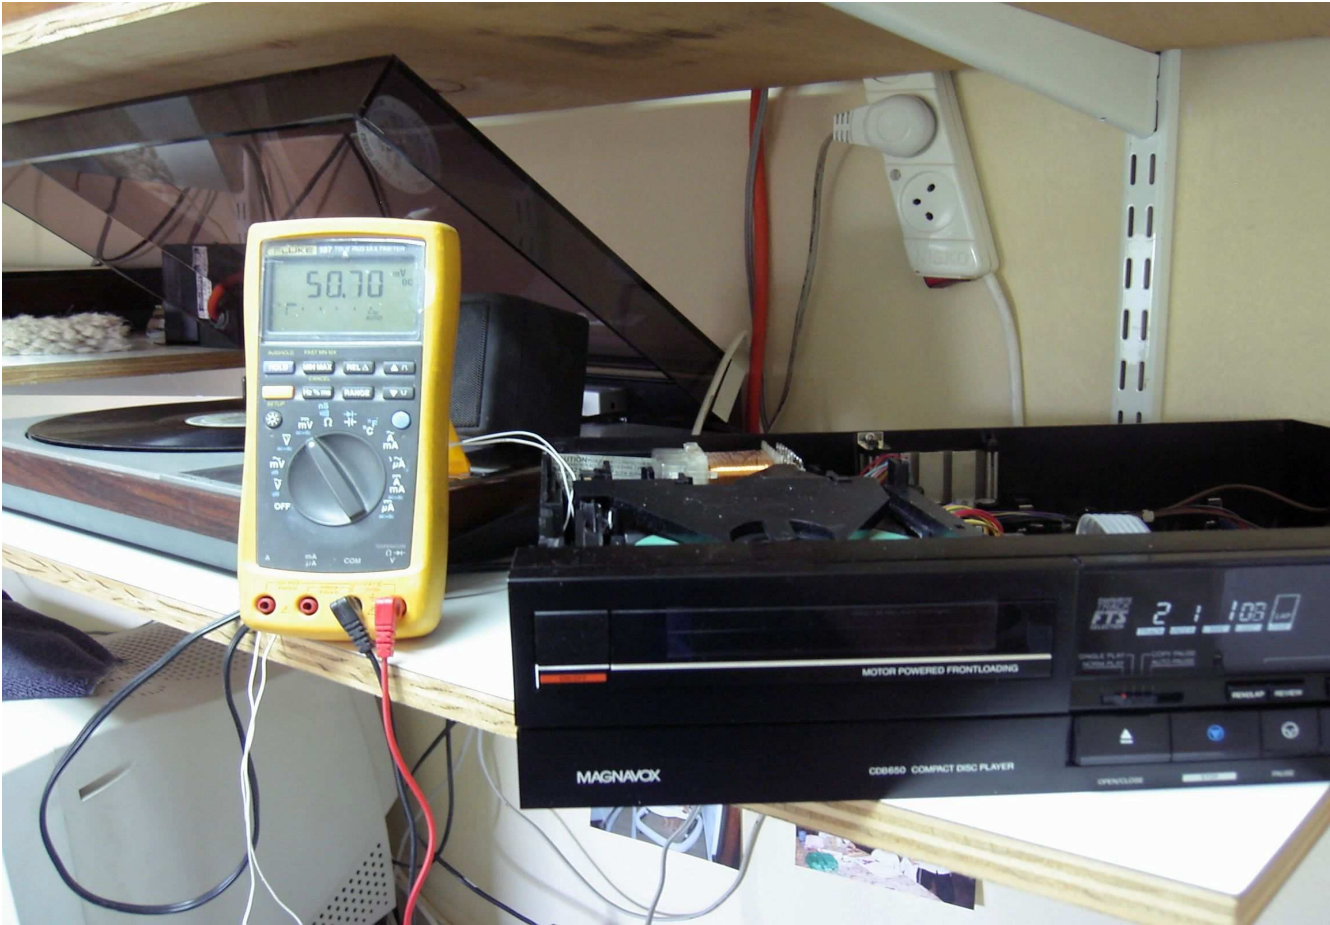
Here you can see the reading of 50.7mV on the Fluke Multimeter

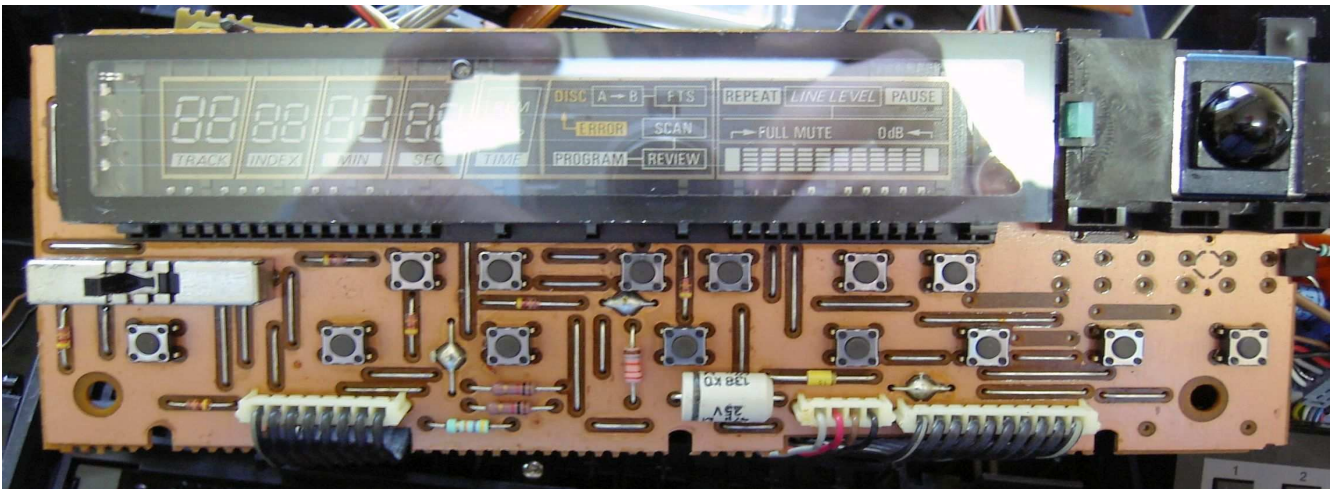
Above is the front-most PCB, with the new Vishay 138 axial capacitor, and immediately next to it, is the new 15V Zener diode, which was mentioned in Part 2 above.

To replace the TMS3763CNL Display Driver IC, I had to desolder the LCD display completely, in order to gain access to the IC underneath it.

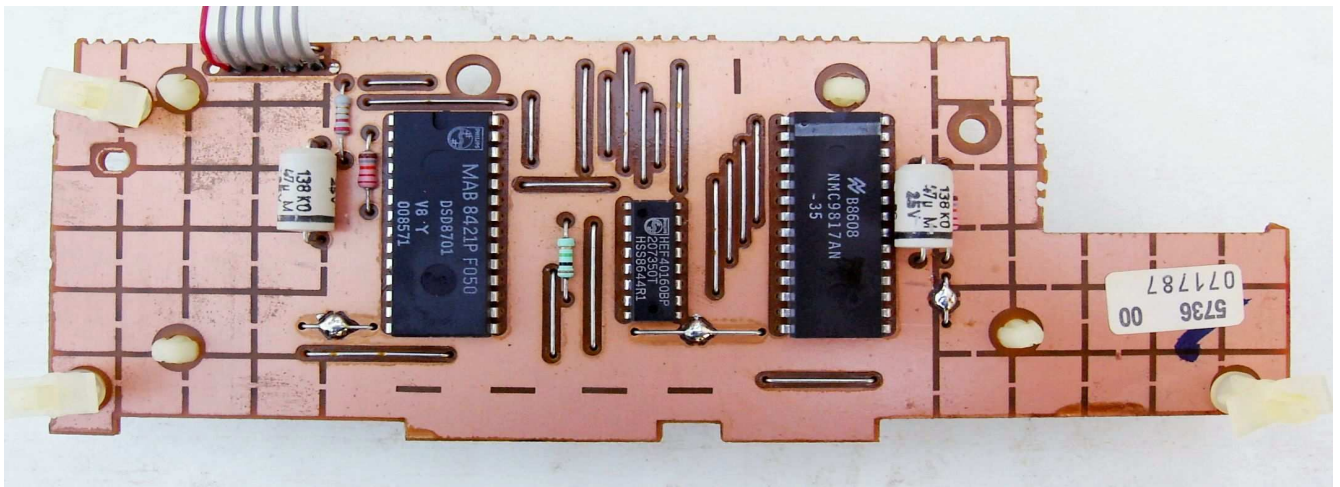
Above is the Display panel's middle PCB, showing the replaced Vishay 138 axial capacitors.

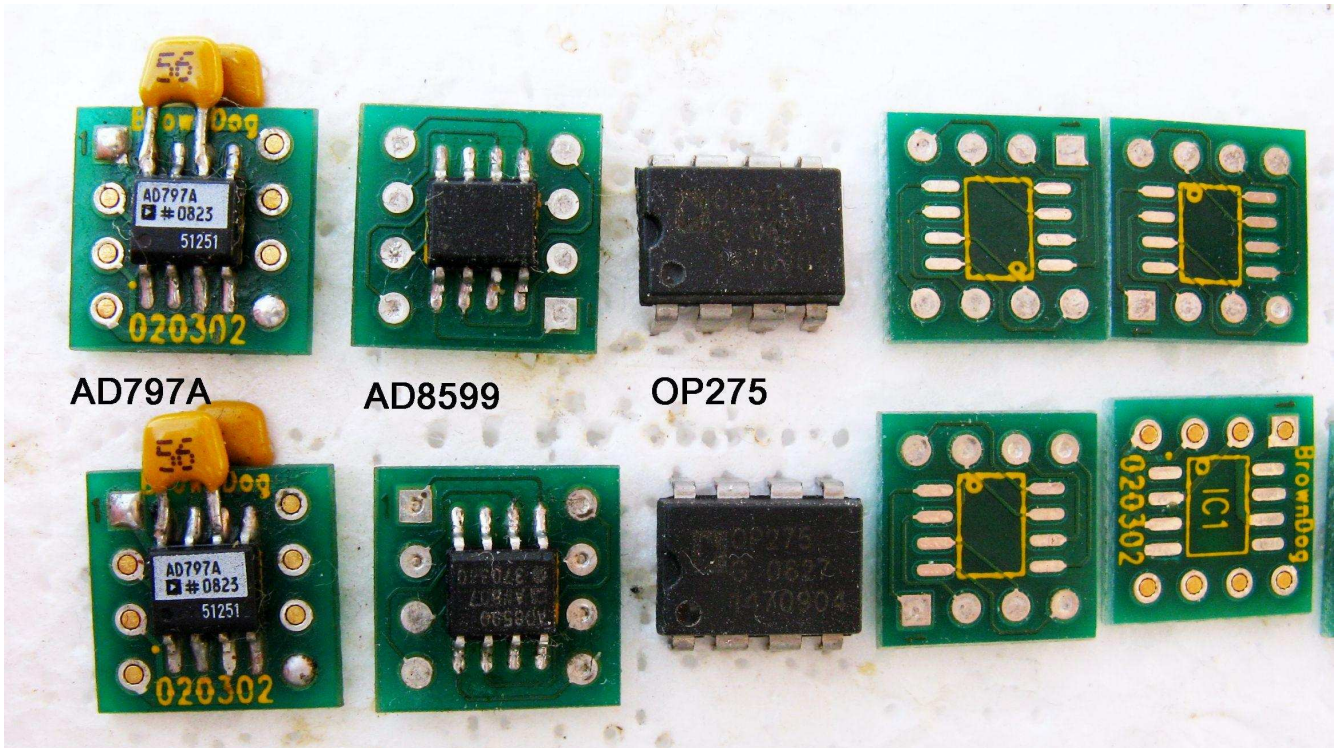
Above are some of the OpAmps I tried, and you can see the 56pF compensating capacitors (Output to GND) on the AD797A. Unused Brown Dog adapters are on the right.

As mentioned in Part 3 above, I installed sockets for the OpAmps. The amplifier stage has 2 NE5532N Dual OpAmps, in the Dip-8 format. In its day, the NE5532 was a top-quality BiPolar OpAmp. Today, there are better choices. The power rails to the OpAmps are +14.6VDC and -14.6VDC. This allows us a wide choice of possible OpAmps. Most of the newer OpAmps are no longer available in Dip-8 format, so I used Brown Dog Adapters to mount the SMD chips. I tried many OpAmps, and the finalists were the AD797A, AD8599, OP275, and OP2134. For pure musical enjoyment and soundstage, my ears preferred the OP2134, and that's what's mounted in there permanently!

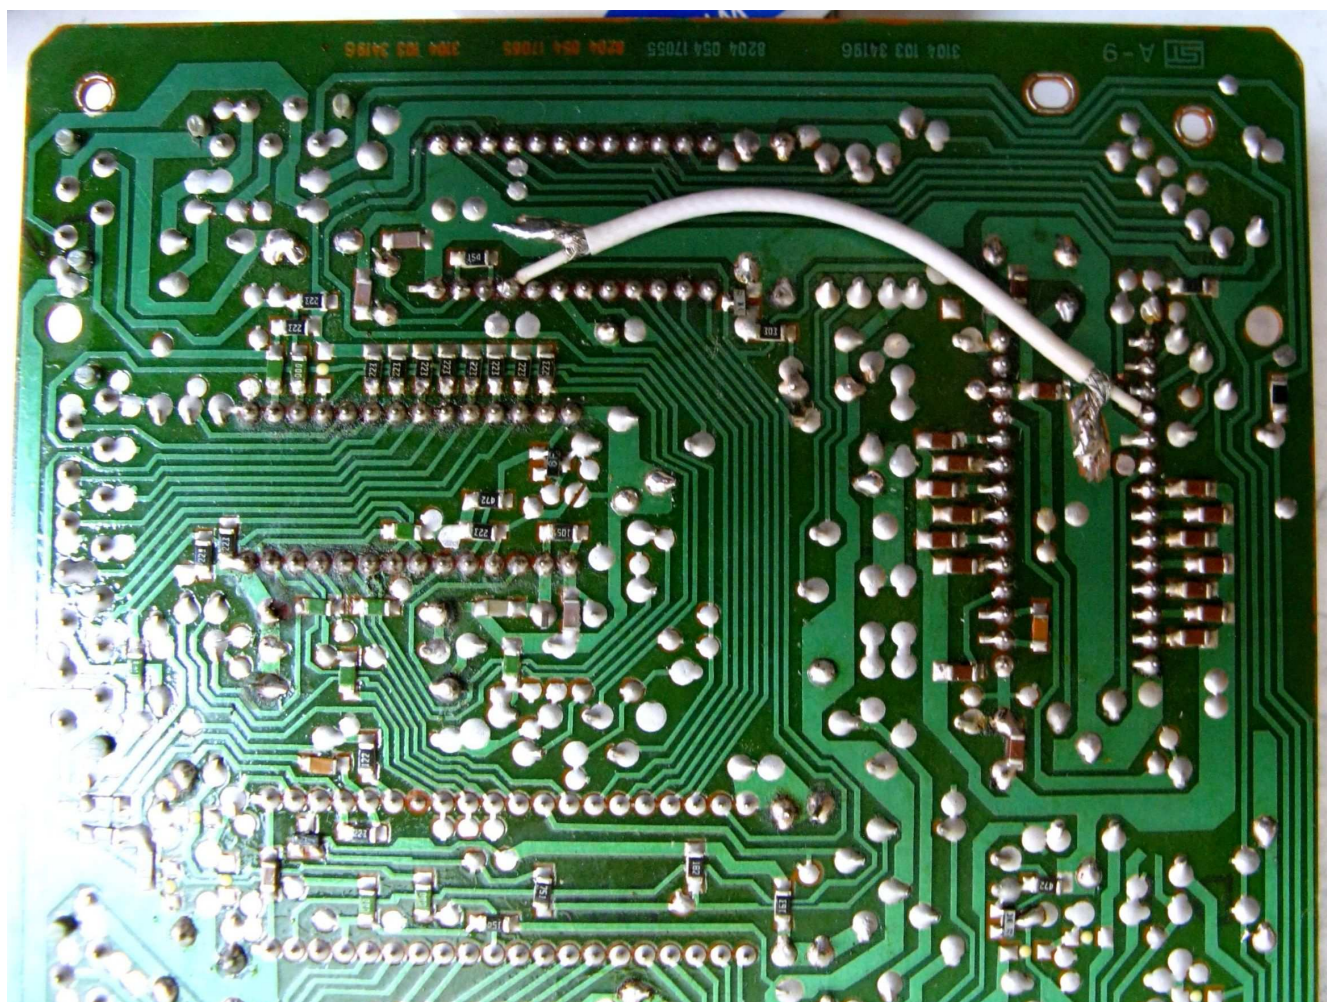
I have separated TDA1541 Pin2 from Pin4, and connected TDA1541 Pin4 SCK directly to SAA7220 Pin9 XSYS via a high-quality Teflon coax cable.

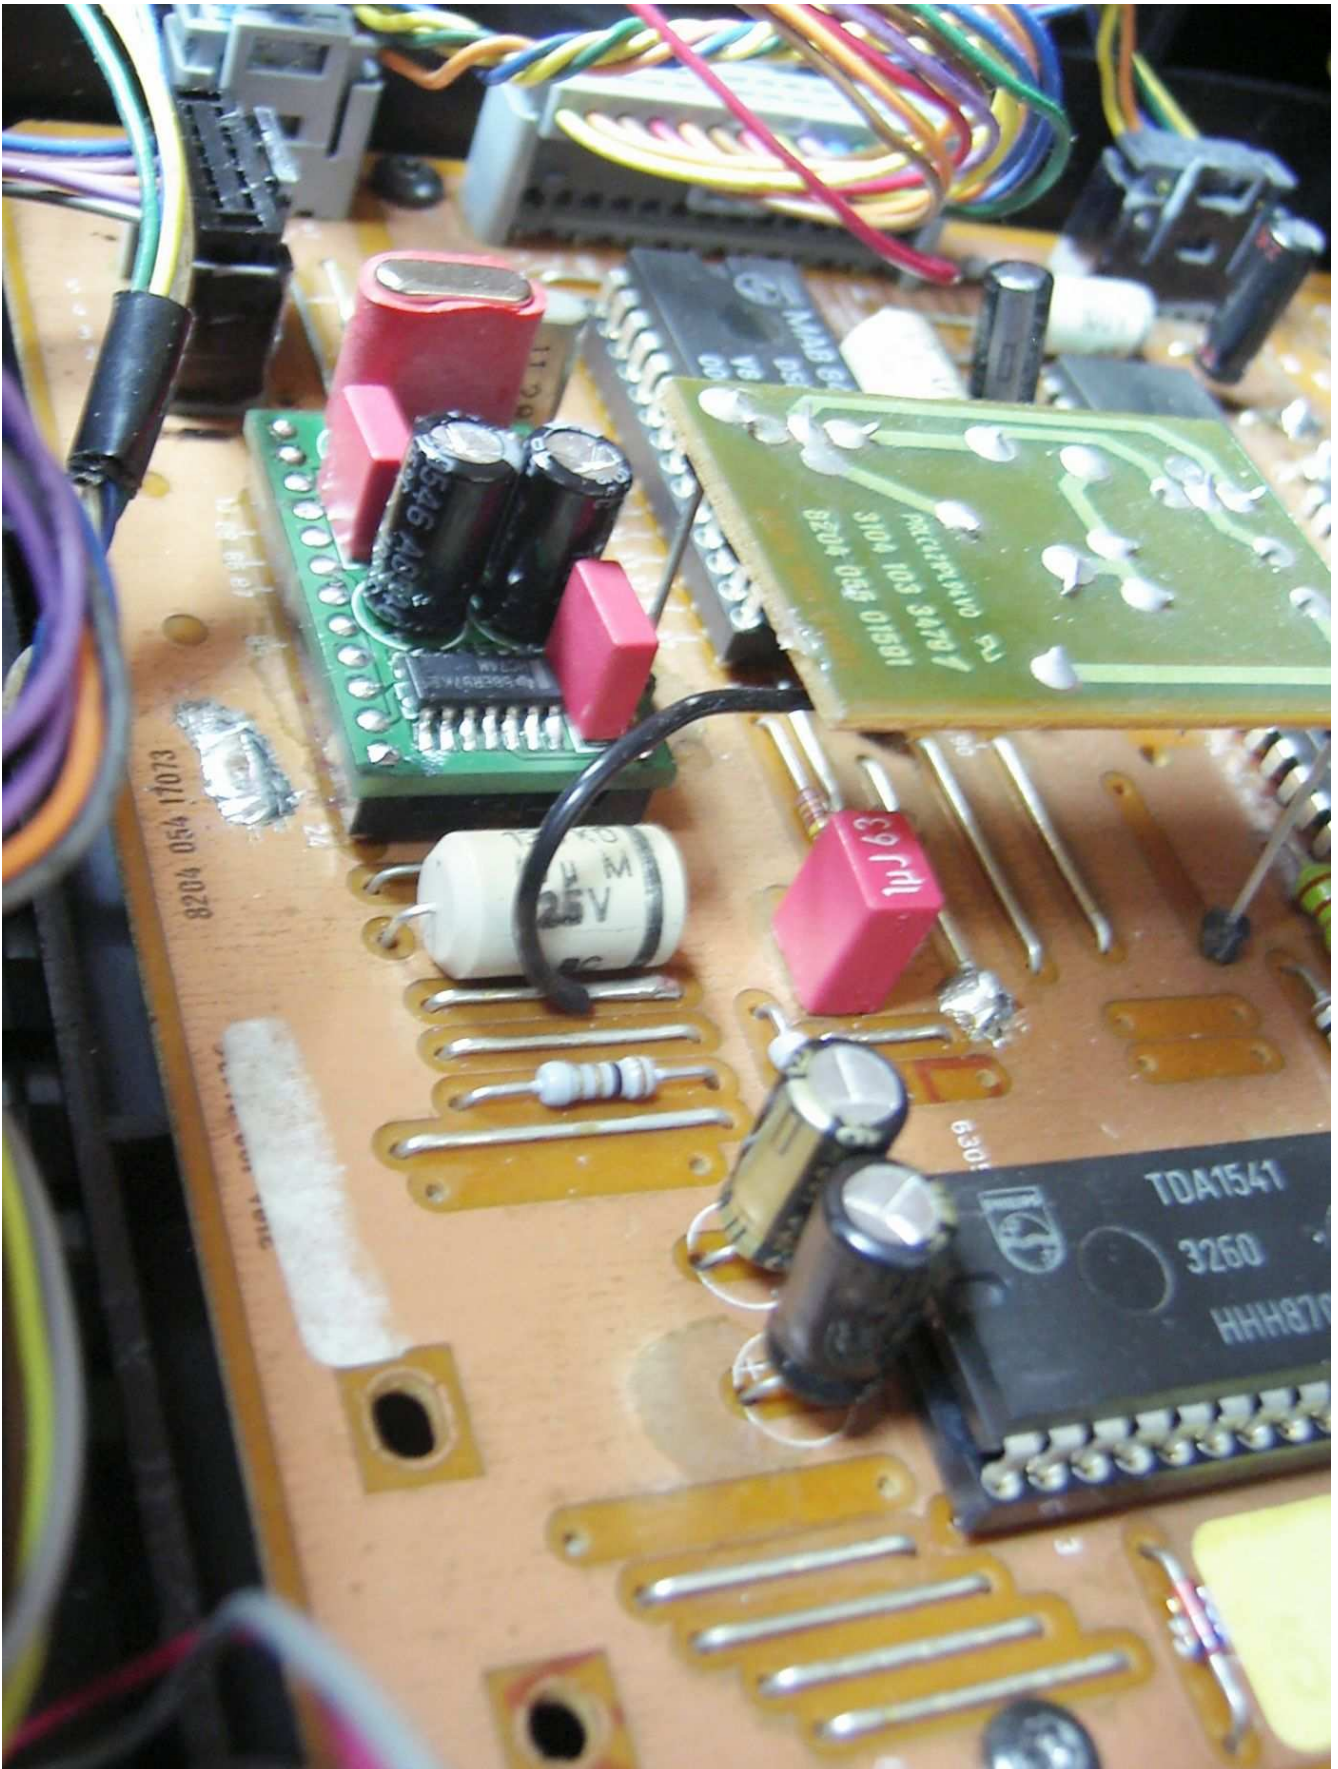
This is a close-up of the NetAudio NOS mod, installed in the SAA7220's socket

This is a very easy mod to do, as it requires only the removal of the SAA7220 chip, and the insertion of the NOS mini-PCB, a pin-for-pin replacement.

This mod bypasses the filtering and oversampling circuitry controlled by the SAA7220, and has a good-quality low-jitter clock. A higher-quality crystal can be supplied at slightly higher cost. I chose the most basic model, to see of what improvement it is capable.

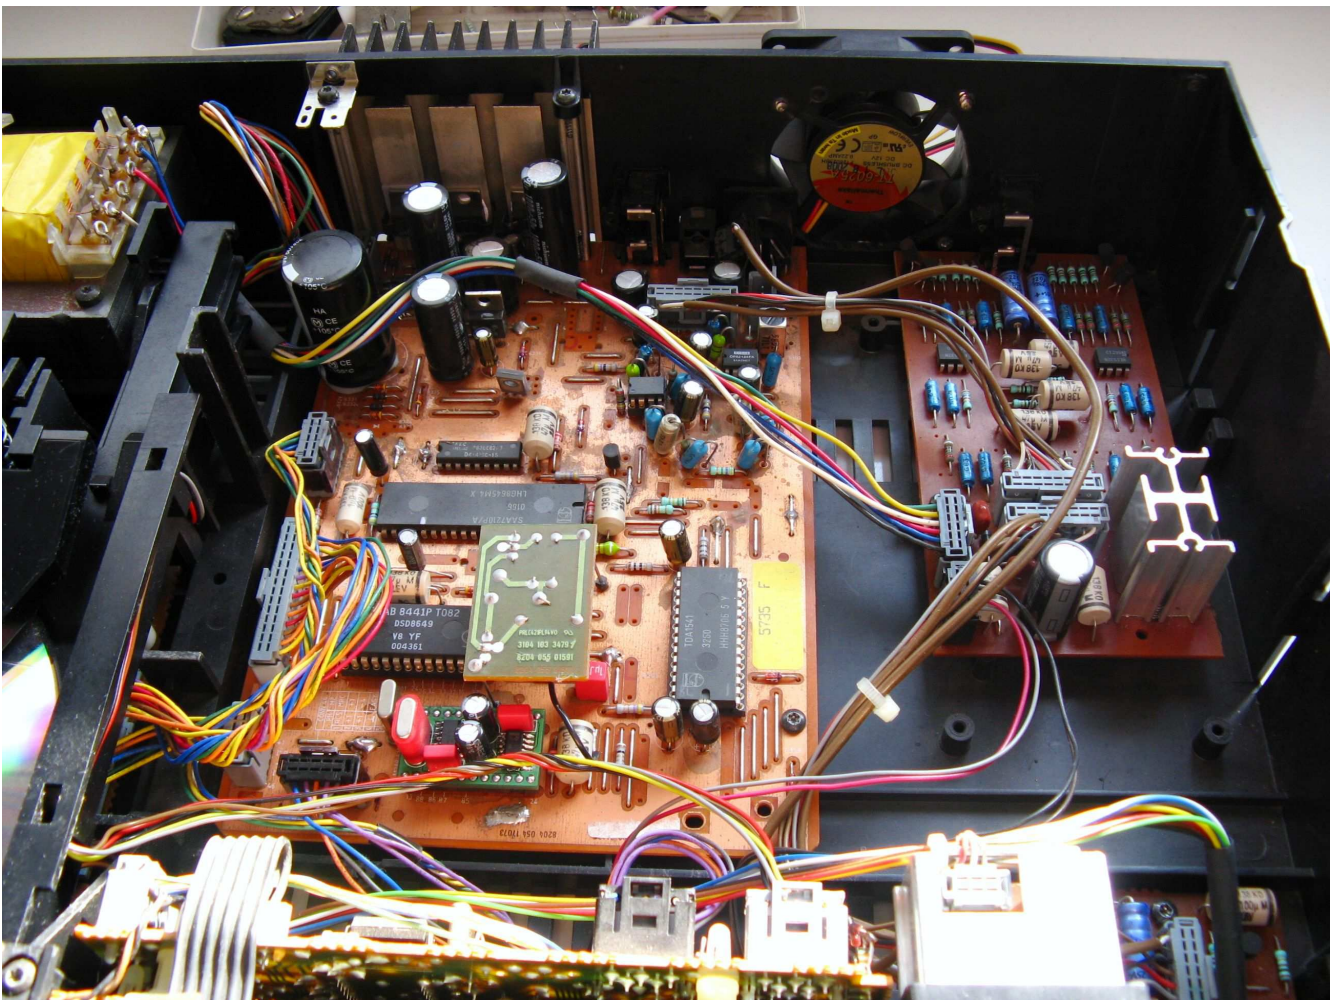
**Completed Interior** – Here you can see the NOS mod, the socketed OpAmps, and all the colourful new wiring harnesses. At the rear, is the new 60mm square fan, for added cooling.

This CD650 is well-known for running hot! I installed a 12V Thermaltake 60mm square fan at the rear, between the Main and Filter PCB's.

The airflow is directed from the outside to the inside, to provide direct cooling onto some of the hottest components, namely the heat-sink on the Filter PCB's 24V Regulator.
