Audio Restoration Project: Repair B&O Bang and Olufsen BeoGram 4000 / 4002 / 4004 / 6000 Tangential Turntable

This article describes how to perform a complete restoration of this model, including taking care of all known failures and defects. The Manufacturer's Service Manual, available from BeoWorld, is an integral component of the proper restoration process.

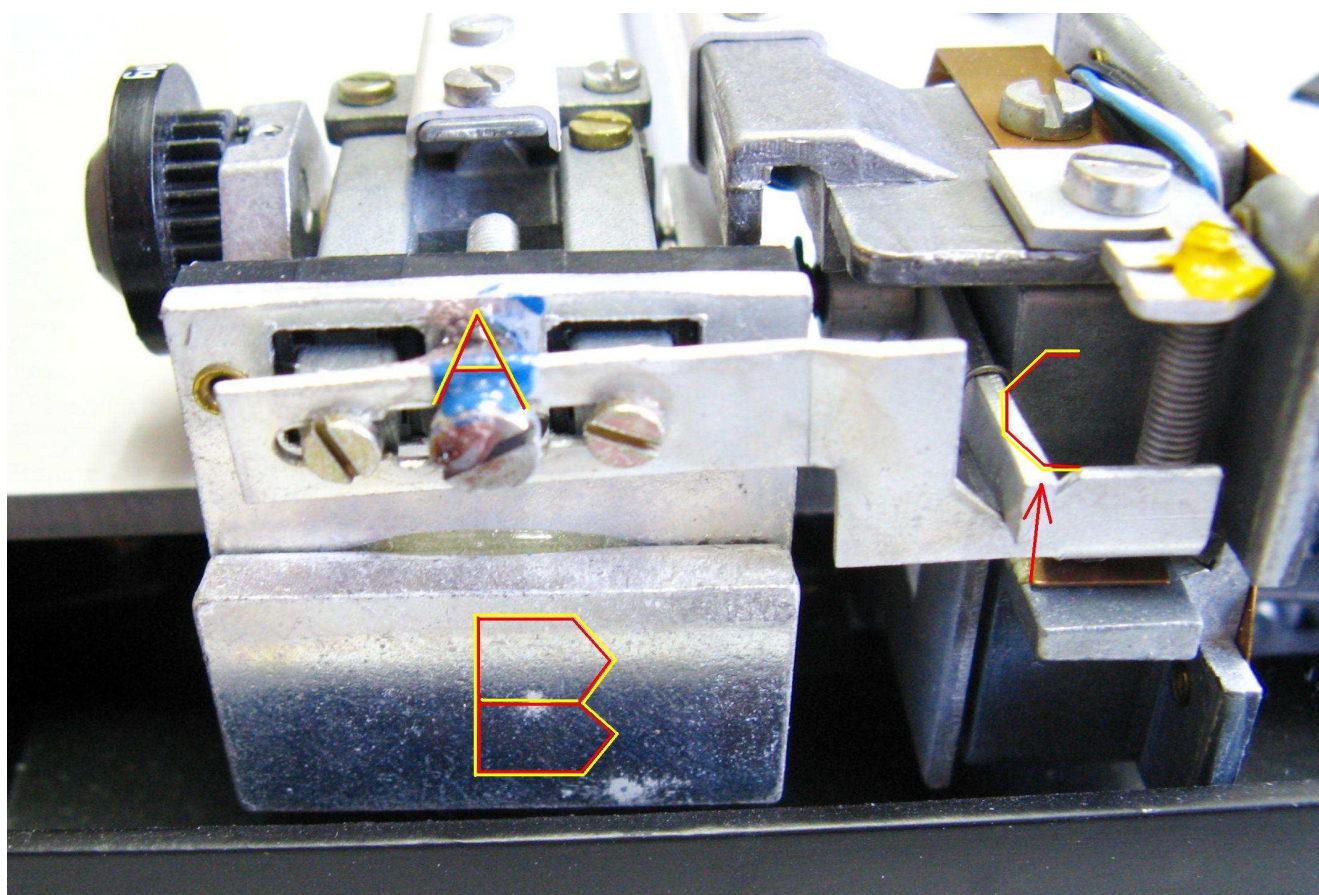
Over time, the bolt (A) holding the tone-arm's counterweight (B) works itself loose, and the tone-arm is no longer in perfect balance. Sound is adversely affected. Leave the cartridge attached to the tone-arm during this procedure.

1. Set the round Tracking-weight wheel to 0 grams.
2. Lift up the spring-loaded arm (C) , and keep holding it up.
3. Tighten or Loosen bolt A (sometimes it may have old lacquer securing it), all the while tapping the tone-arm gently, until you feel that it is in perfect longitudinal balance.
4. Release Arm C, apply new lacquer on bolt A, and rotate the tracking-weight to that appropriate for your cartridge.
5. Other mechanical adjustments need to be made – reference to the Service Manual is recommended.
