Audio Restoration Project: Repair B&O Bang and Olufsen BeoGram 4500 Type 59xx Tangential Turntable

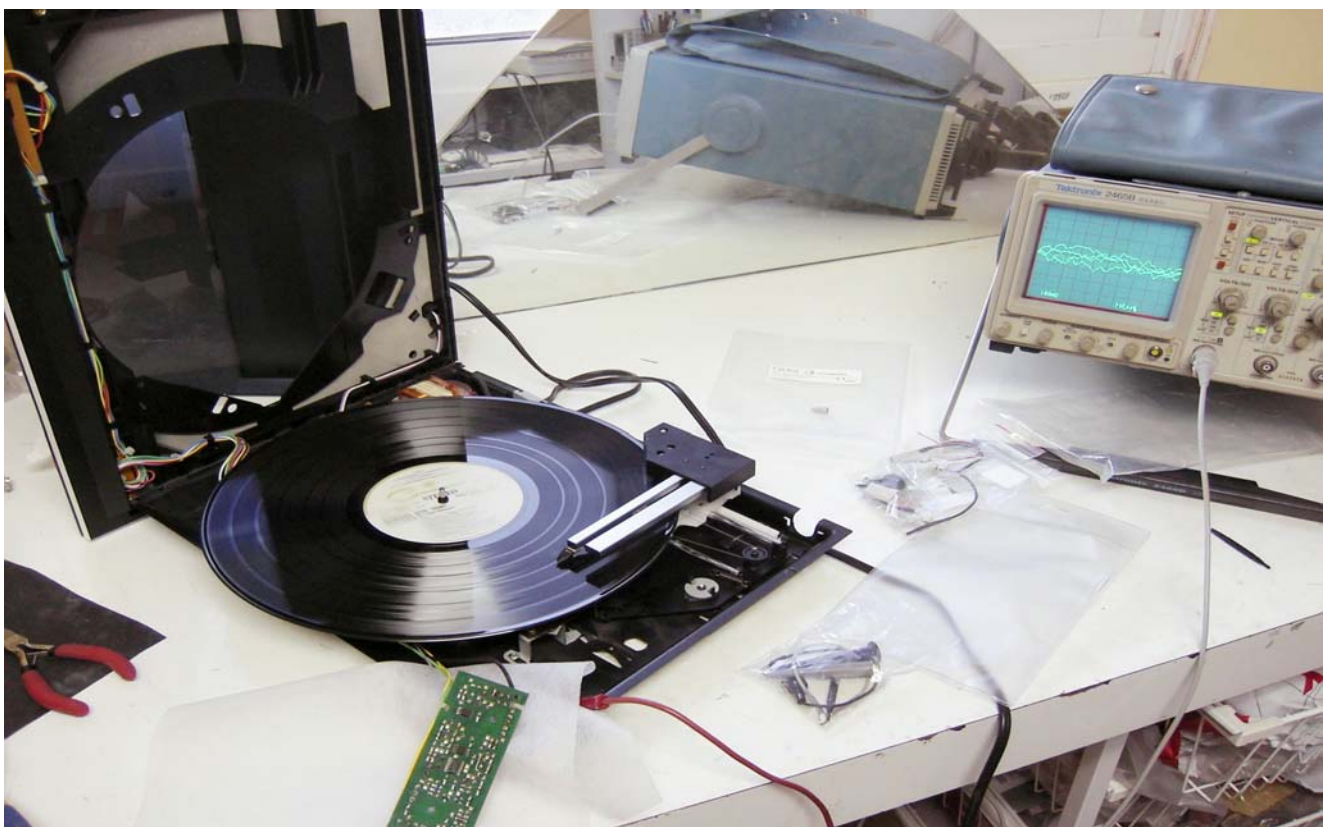
To open the unit, first remove the cartridge stylus, then slide the tone-arm all the way to the left, remove 2 small screws on the right panel underside, and raise up the right edge to the vertical, as it is hinged on the left side.
