Audio Restoration Repair Project: Bose FM / AM Wave Radio receiver, and conversion from 110-120VAC to 220-240VAC

This particular version, manufactured in 1997, is a very well-made unit, capable of long-life, with satisfying sound.

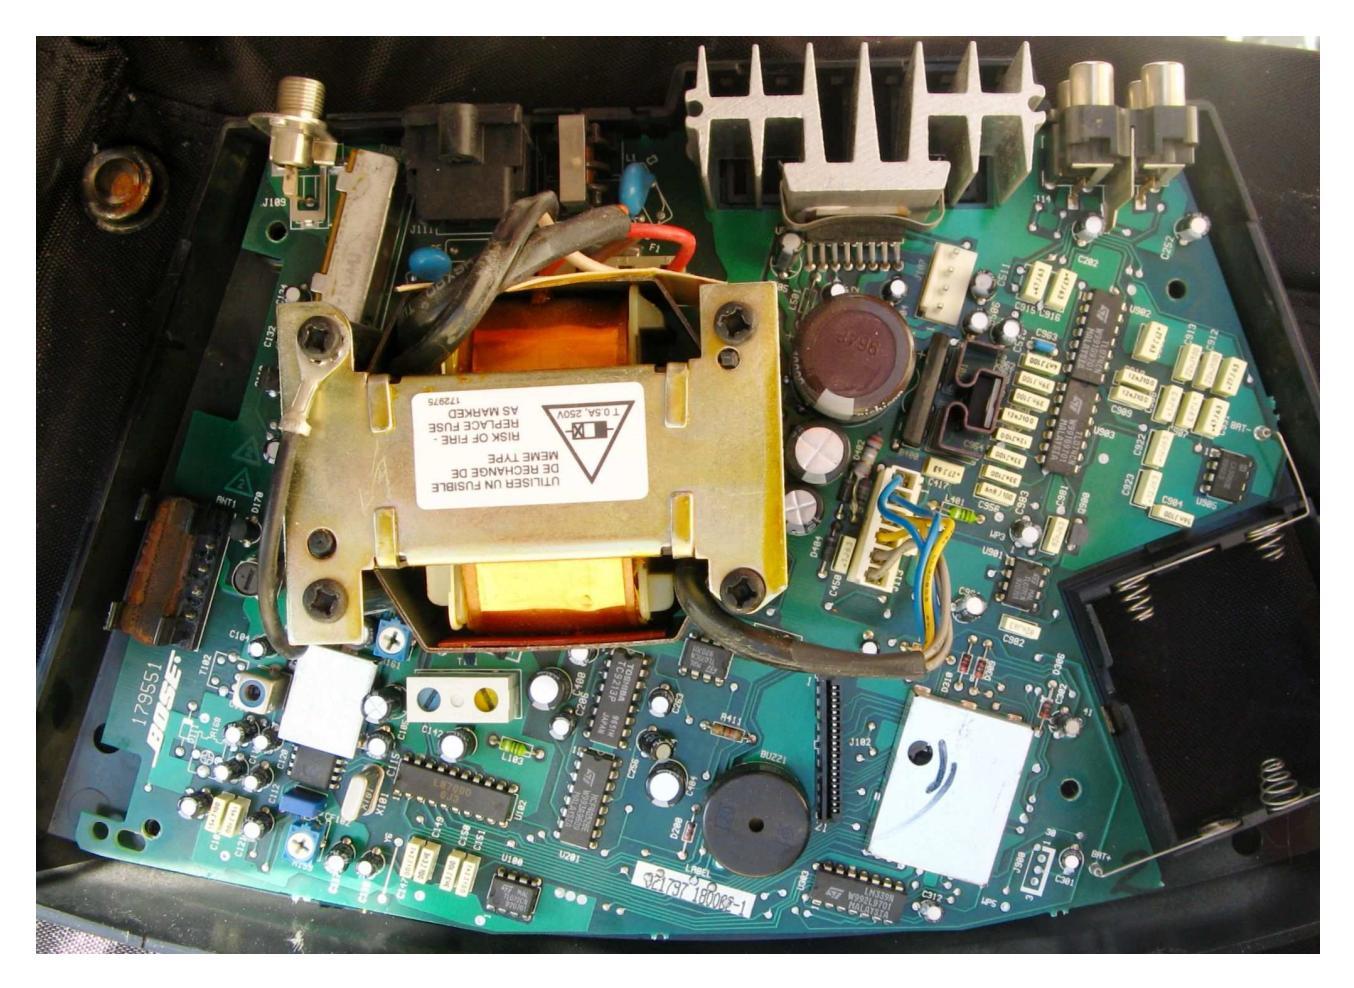
This is the main PCB before starting work

Here you can see the main PCB. The input voltage at the top left, the power section is at the centreright, the tuner section at the left, the signal processing at the bottom center, and the audio section at the right side.

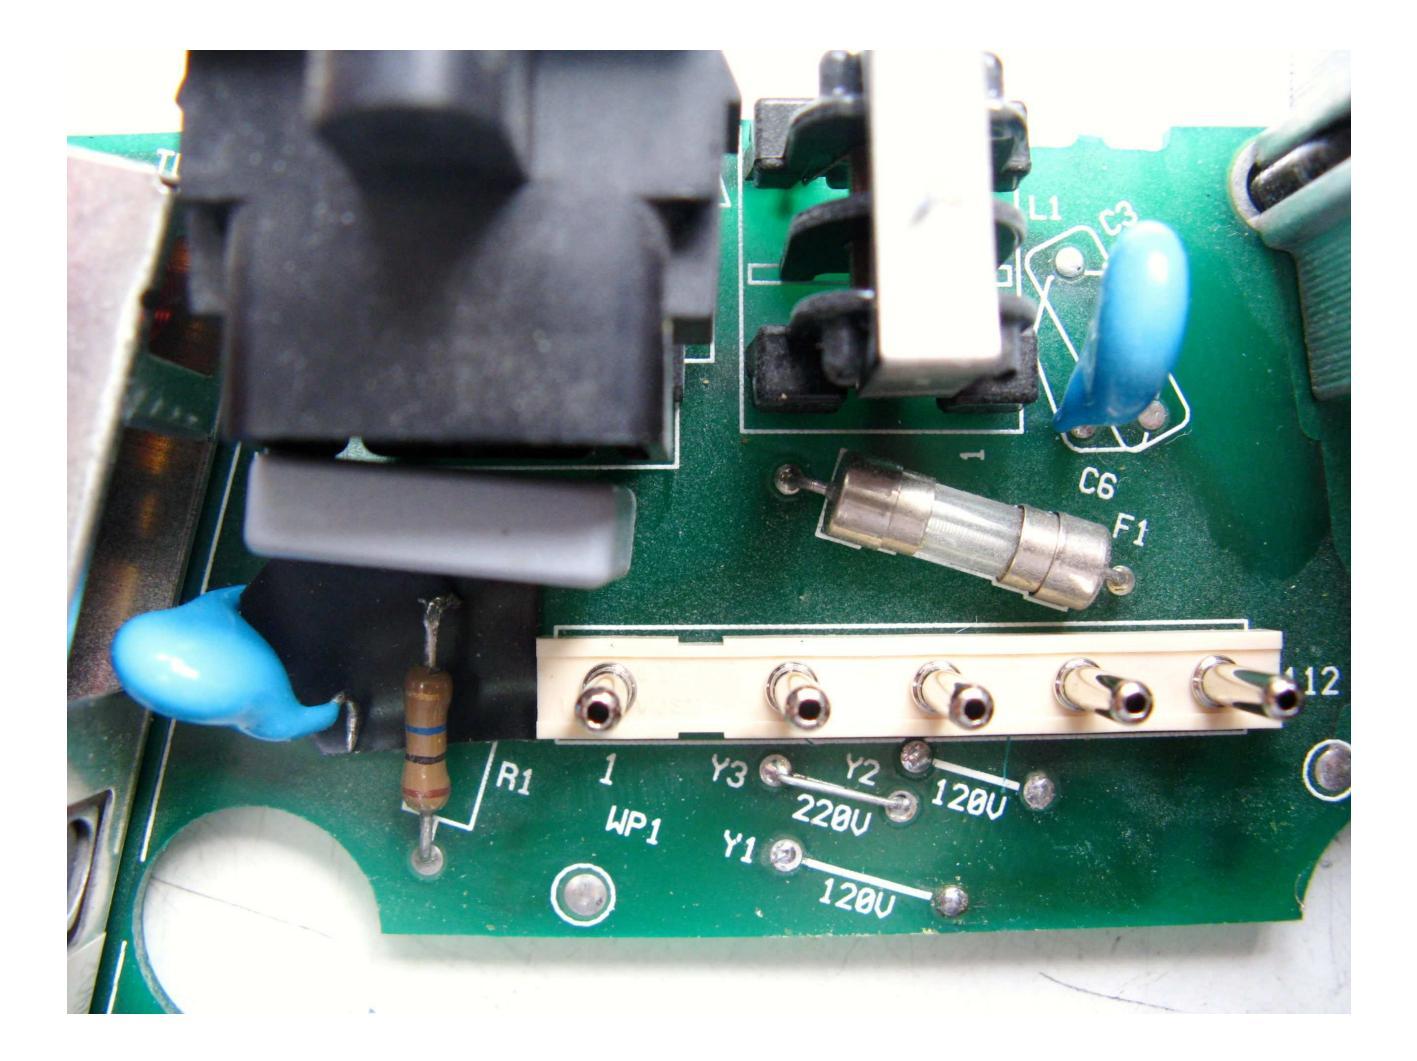
1. Conversion of input voltage to receive 220-240VAC, instead of 110-120V AC

At the top left of the circuit board, do the following modifications, as shown in the picture below:

- 1. Disconnect from the circuit board, one leg each of C2 and R1. I did not remove them entirely, so as to allow the easy option of reinstallation, if required later.
- 2. At C5 (not populated), install a 4.7nF 275V-310V AC suppression capacitor of only the X2 type. I used a Vishay 339MKP unit. Many neighborhood electronics suppliers do not know about X- or Y-class AC capacitors, rather preferring to convince you to buy a regular film capacitor from their existing stock. Do not believe them for a moment. Installing a regular film capacitor will compromise the safety of your radio, and may destroy it.
- 3. Disconnect jumpers Y1 and Y2, and install a new jumper at Y3.
- 4. Remove F1 (the 120V 0.5A fuse), and replace it with a 250V 0.25A fuse.

At this point, the radio will operate perfectly, connected directly to a 220/240VAC wall outlet.

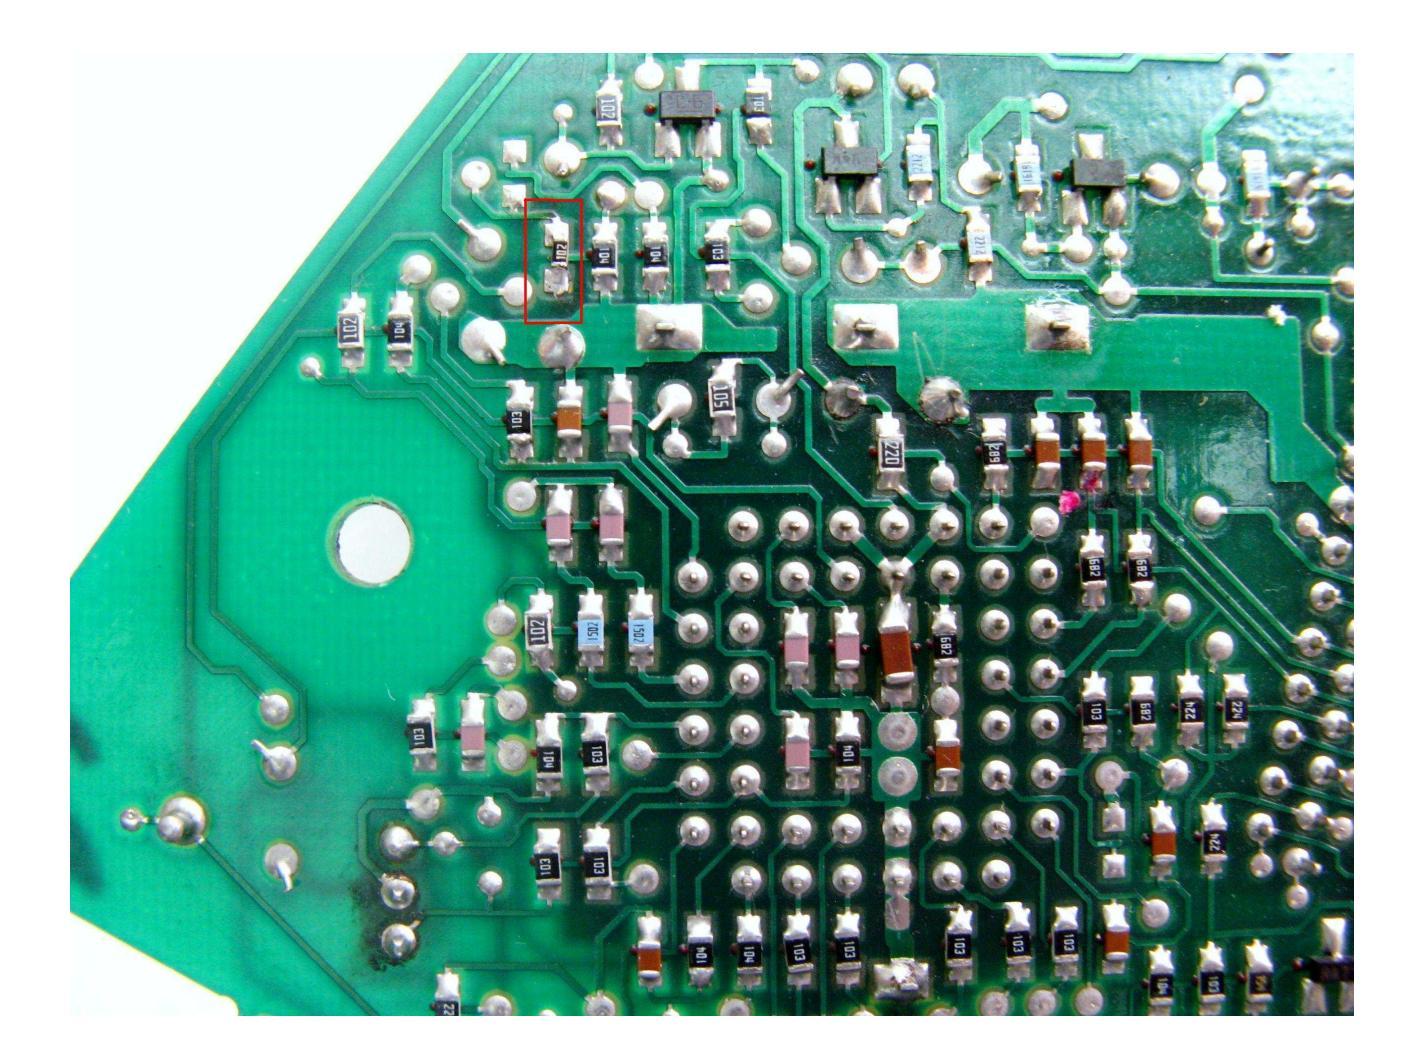
2. Conversion of Tuner - FM 50 kHz spacing; AM 9 kHz spacing

This is controlled by U301 MC68HS705C8 port PD2. PD2 is pulled low (weakly) by R346 100KOhm. To make the change, PD2 must be pulled high ², by installing R360 1KOhm (currently unpopulated).

In addition to the change of spacing, a Euro-spec circuit must be much more selective to be able to listen clearly to the stations, which are located 4 times closer together than in North America.

This next change is very important, to enable clear reception of the closely spaced stations. Remove the original wide 10.7 MHz filters at CF101 and CF104, and replace with narrow Murata 150 kHz units SFELF10M7JAA0-B0.

No additional alignment was required on this particular radio - but your radio may differ.

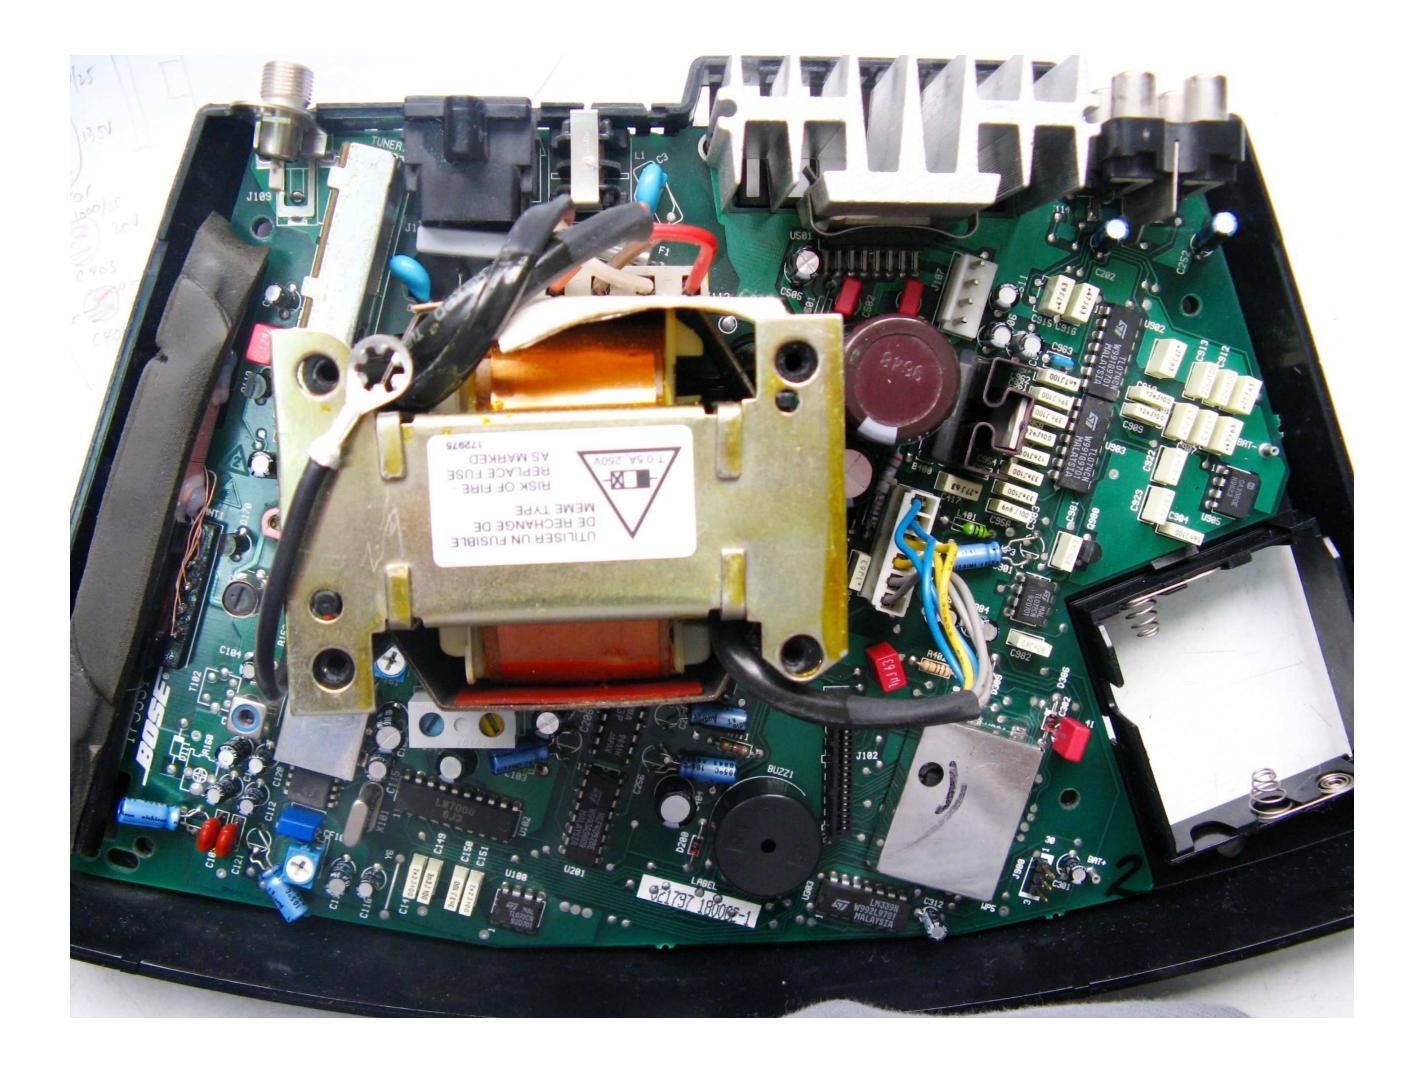
This is the main PCB after completing the modifications

Replace C103 and C121 (currently 15nF), each with a 10nF 100VDC film capacitor ³. You can see them in the picture below – 2 orange capacitors at the bottom left.

On the picture below, you can see some blue Nichicon KT 10uF Audio-grade electrolytic capacitors, and also 4 red Wima MKS2 0.47uF and 1uF film capacitors. Some of them had to be mounted horizontally, because of limited vertical clearance.

Under the metal can at the right (requires desoldering and removal), adjacent to U301, was the only defective capacitor which required replacement - a 47uF unit. Check the ESR on your unit.

These are in the signal path, and replacement with these types will give you a radio which sounds fully alive, and pleased to play all day long.
